## Post-test examination of a Li-Ta heat pipe exposed to H plasma in Magnum PSI

The authors exposed a radiatively cooled, Li-filled tantalum (Ta) heat pipe (HP) to a H plasma in Magnum PSI continuously for ~2 h. We kept the overall heat load on the inclined HP constant and varied the tilt to give peak heat fluxes of ~7.5–13 MW/m<sup>2</sup>. The peak temperature reached ~1250 °C. This paper describes the post-test analysis and discusses Li HPs with materials other than Ta for fusion. A companion paper describes the experiment.

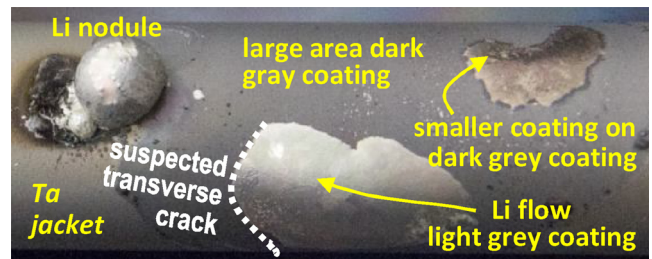
After the dark grey coating had formed, the well-resolved live image of the 2<sup>nd</sup> IR camera showed Li flow from what appeared to be a transverse crack as indicated by the curved and white arrows in Fig. 2. This light grey coating wetted an area ~30 mm<sup>2</sup> and thickened with a slight bulge. The description here is a recollection of the live image. The IR camera had stopped recording before this time, and the flow was not visible in the video cam.

Fig. 2 was taken on a workbench while the HP was briefly exposed to air. The nodule and light grey coating were shiny at first. Then, slowly, oxidation began to reveal the grain boundaries, which are apparent in the images. The smaller coating also flowed over the dark grey coating. Both have closed perimeters and overlay the dark grey coating. So, we presume the same process formed these as formed the light grey coating. Adjacent to the nodule are the dark fans of a leaf-like structure.

Fig. 2. Li-Ta HP just after removal from Magnum PSI.

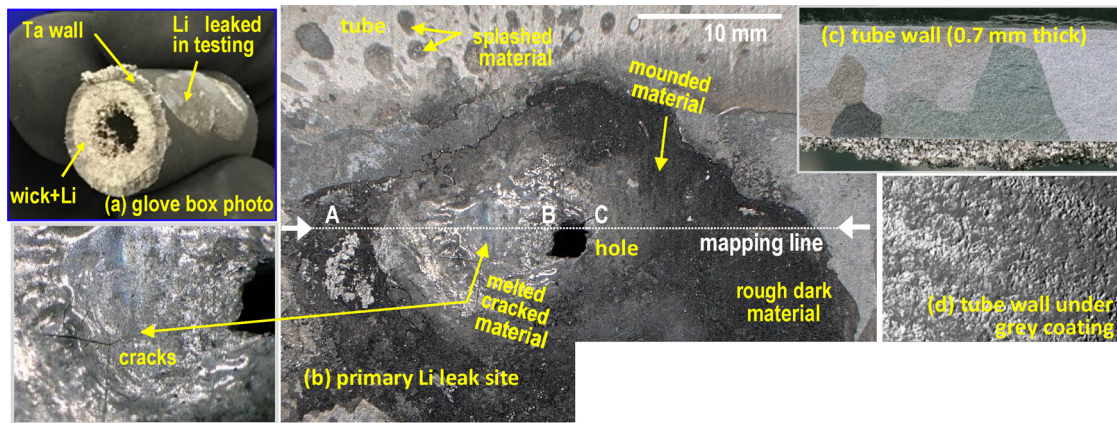
Fig. 3b shows the pinhole failure site of the primary Li leak. Splashed and mounded material overlaid the tube surface. The mounded surfaces (at A and C, Fig. 3b) were ~40 μ above the tube wall. The shoulder (B) of the deep hole was ~250 μ below the tube prior surface. Material to the left of the hole had melted and cracked.

The large grains in Fig. 3c indicate recrystallization. In places a single grain spanned the Ta wall thickness.

An SEM exam of the surface under the light grey and dark grey coatings (Fig. 3d), revealed a few small holes but no large crack at the site shown in Fig. 1. The surface under the coatings was like the other side of the pipe which was had been hot but not but not exposed to plasma.

Fig. 3. (a) glove box photo, coatings, no nodule; (b) primary Li leak site, 0.2 x 0.3 mm hole; (c) Microstructure of 0.7-mm-thick Ta wall; (d) Ta tube surface under grey coatings.

Nor did we find evidence of any leak beyond the primary leak site. The following conditions made this a likely failure site: single grains spanned the wall; this site reached highest temperature; the HP contained Li3N and other impurities to promote corrosion. The following observations indicate the Li3N came from the HP, rather as a nitride formed after Magnum-PSI was vented. The coating’s dark shade was evident when the light grey coating formed, and when we removed the lid from the chamber and observed the HP still under a blanket of argon. At that time, the smaller coating was still shiny.

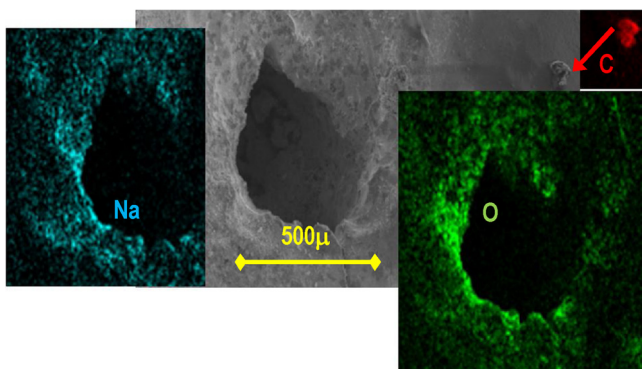
Fig. 4 shows element maps of surfaces at the primary leak site. Oxygen (O) and sodium (Na) were significant. Only a single small blob of ejected carbon (C) or a carbide was found, so C was not widespread.

Fig. 4. SEM photo of pinhole leak site and elemental maps of surface impurities.

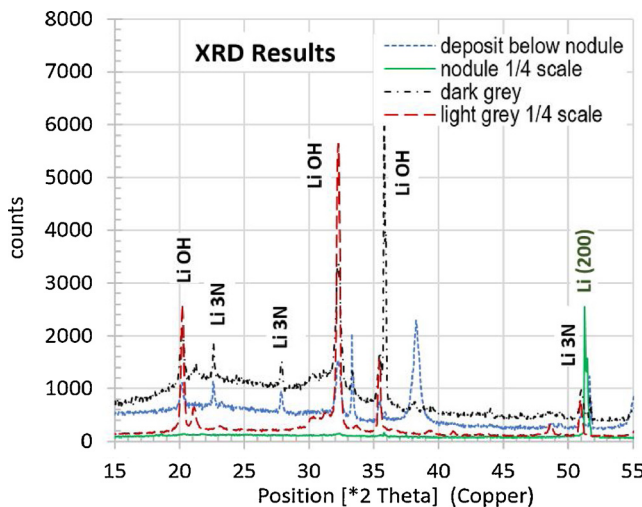
Strong (200) and (211) lines indicate that the nodule was metallic (amorphous) lithium. The coatings contained crystalline material. The dark grey coating was composed of LiOH and Li<sub>3</sub>N, as was the black deposit below the nodule. The latter had trace amounts of an unidentified phase. The light grey coating was predominantly LiOH. The Discussion Section explains how this coating formed.

Fig. 5. XRD results for the Li nodule and coatings.
