## Operational impact on the JET ITER-like wall in-vessel components

V. Riccardo<sup>a,b,\*</sup>, G. Arnoux<sup>a,b</sup>, S. Collins<sup>a,b</sup>, P. Lomas<sup>a,b</sup>, G. Matthews<sup>a,b</sup>, N. Pace<sup>a,b</sup>, V. Thompson<sup>a,b</sup>, JET EFDA Contributors<sup>1</sup>

The JET ITER-like Wall (ILW) provides the same plasma facing component configuration as ITER during its active phase: beryllium in the main chamber and tungsten in the divertor. Moving from a carbon-based wall to an all metals wall requires some operational adjustment. The reduction in radiation at the plasma edge and in the divertor can lead to high power loads on the plasma facing components both in steady state and in transients and requires the development of radiative scenarios and the use of massive gas injection to mitigate disruptions. These tools are even more important now because an all metal wall is much less forgiving to thermal overloading the carbon based wall used to be. Here the impact of the first 11 months of operation on the ILW plasma facing components is discussed.

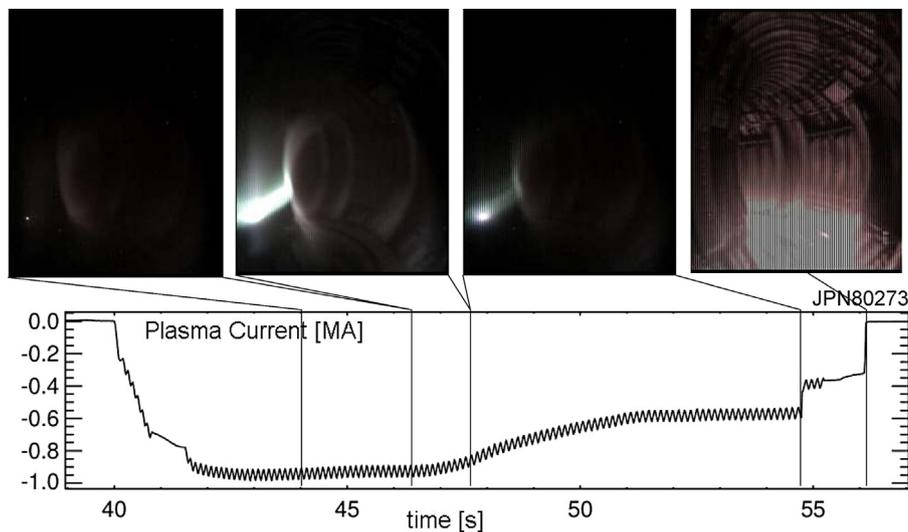
Fig. 1. Slide-away event in pulse 80273 which caused minor damage to one inner wall tile assembly.

stopped and the small amount of gas in the torus was ionized and accelerated to relativistic speeds. The chain of events was unraveled and a solution devised, but not implemented in the pulse schedule handling software before the same spurious plant alarm reoccurred. The second event, pulse 80273 shown in Fig. 1, consisted of  $>900$  kA for 5 s and followed by  $>600$  kA for a further 9 s. The beam came into contact with the inner wall occasionally as well as in its last instability. This resulted in some very localized damage to beryllium limiters (the size of two half castellations,  $12\text{ mm} \times 12\text{ mm}$  in one toroidal position) and to several of the tungsten coated CFC tiles protecting the bottom of the inner wall guard limiters. Once the revised requirement for gas injection was implemented in the pulse schedule handling software, no event like that happened in the rest of the 11 months of operation. Fortunately, the location of contact between the slide-away beam and the inner wall guard limiter was sufficiently remote from the plasma separatrix not to affect the subsequent plasma operation.

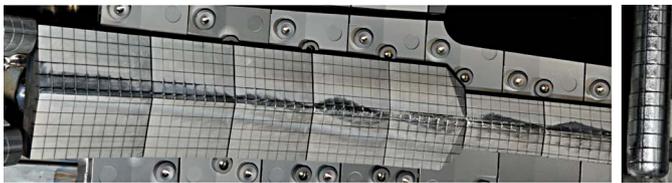
Fig. 2. Examples of superficial melt damage to the upper dump plate and inner protection.

The higher convective heat loads caused by the reduction of radiated power during the current quench have caused superficial damage on the upper dump plates and the upper inner protection plates, as shown in Fig. 2, because disruptions in the ILW tend to go more often upwards, even at relatively low plasma current (for example, a 2.5 MA event took the span of several castellations to melting temperature). Although this damage is inconsequential to plasma operation, it could become more substantial at higher plasma currents and cause problems elsewhere in the main chamber; small drops on the divertor were often observed and burnt off in a few pulses without affecting performance, larger ones could become noticeable.

To reduce heat loads and to manage electro-mechanical loads massive gas injection has become mandatory for plasma currents above 2.5 MA and has so far been seen to successfully mitigate disruptions [2].

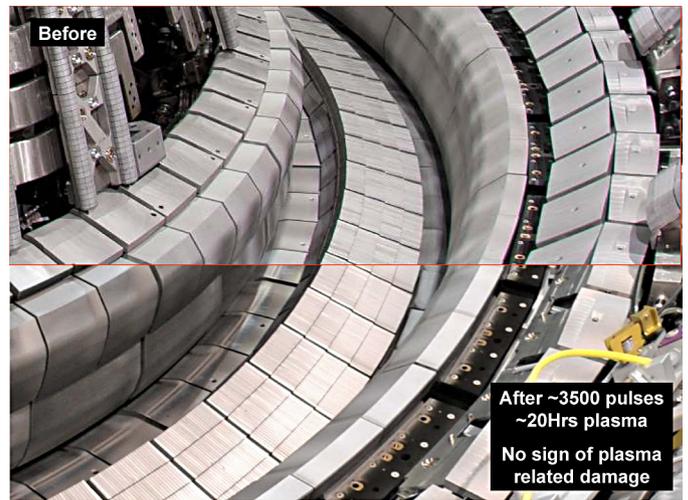
Fig. 4. Split view of the divertor (before at the top and at the bottom after 11 months of operation) showing bulk tungsten and tungsten coated CFC tiles, both exhibiting little sign of wear and tear.

Fig. 4 shows a split view of the divertor before and after 11 months of plasma operation. Apart from some discoloration due to erosion and deposition, there is no evidence of delamination due to thermal fatigue or de-bonding in the tungsten-coated tiles in either the inner or outer divertor. The bulk tungsten divertor tile has been tested close to its energy and surface temperature limits

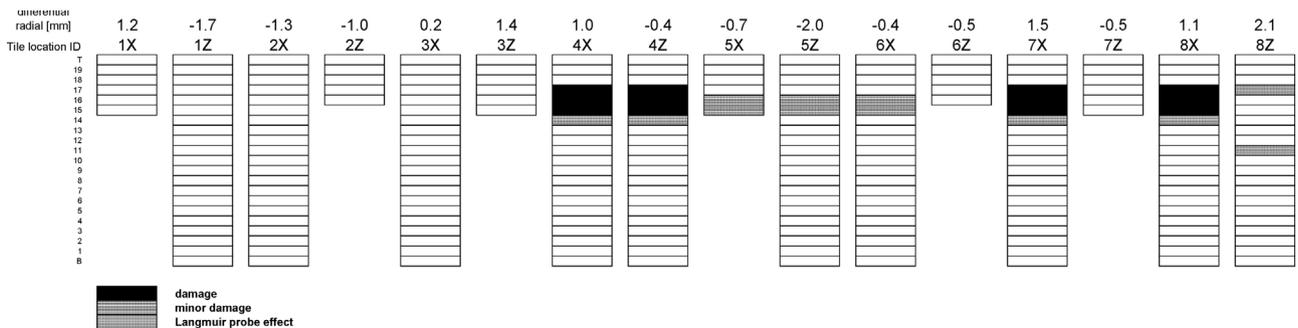
plumes left the tiles at times consistent with spikes in beryllium radiation. Following the in situ high resolution photographic survey more melted locations were found. The pattern of melting on the inner wall is shown in Fig. 3. This pattern seems to support other observations [8] that the scrape off layer is very thin, and the slight relative misalignment of the limiter beams (also reported in Fig. 3) could be sufficient to explain the toroidal asymmetry of the heat load.

Although it was undesirable to melt the inner and outer limiter tiles, this has provided an experimental confirmation of the power handling capabilities of the tiles, which can be used to tune the administrative operational limits: starting at 400 °C, 4.4 MW for 10 s in limiter configuration are sufficient to reach beryllium melting temperature. Having decided to replace the damaged beryllium slices only on the outer wall, the inner wall tiles can be used to monitor the progress of the damage and its effect on plasma operation. In addition, having reached melting with a single configuration and only 2 or 3 pulses in each location offered the opportunity to study beryllium melt layer physics [9]. The liquid beryllium is moved against the gravity force. This required a current density higher than 6 kA/m<sup>2</sup>, much more than can be sustained by thermo-emission at the melting temperature, only possible accounting for secondary electron emission and plasma pressure force.

Fig. 3. Schematic map of the inner wall plasma limiting tiles showing the locations where melt occurred.

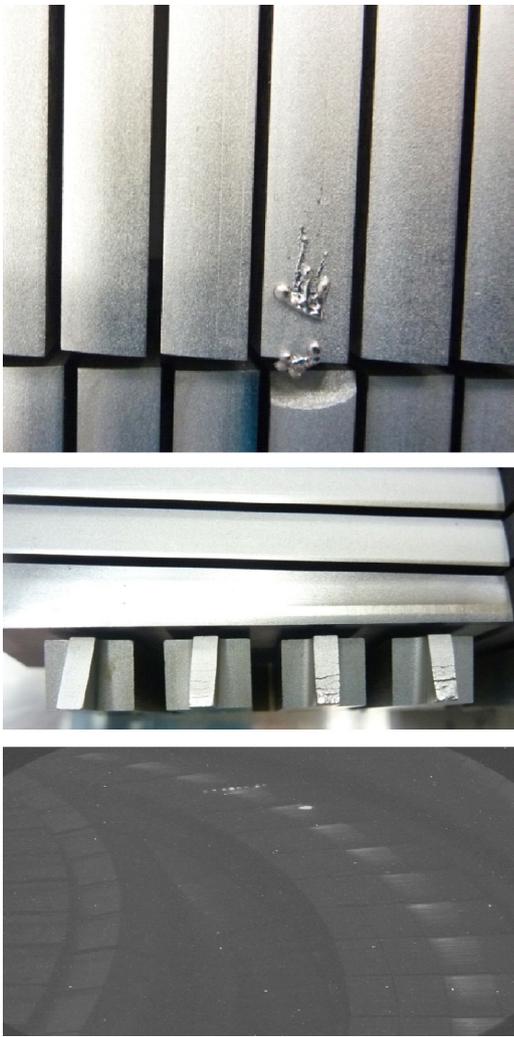
**Fig. 5.** Collection of tungsten melts: (top) inboard edge of one lamella on the outermost stack; (middle) Langmuir probe tips melted and cracked; filtered visible camera view showing one set of Langmuir probes (top chain of dots) and the lamella melt of the top picture (large isolated hot spot).

As far as we know only one location had melted tungsten, rather than beryllium. This was in the same module as one set of Langmuir probes and in view of one of the near infrared cameras, as shown in Fig. 5. This camera recorded the presence of the hot spot due to the melted globule of tungsten generated since a filter was added till the end of plasma operation, that is  $>1000$  pulses, including those with the strike point in the vicinity of the globule and the highest neutral beam power achieved in this operational period. This observation shows that operation with a limited amount of misshaped tungsten is compatible with operation, as it went unnoticed until it was found during ex-vessel inspection of the tile. The location of the lamella chip is rather fortunate, as the outboard edge of the lamella adjacent on the inner side (top in Fig. 5) shadows it for most plasma configurations.

Fig. 5 also shows the damage accumulated by the divertor Langmuir probes. There are signs of melting on some of the Langmuir probe tips in all poloidal positions and in all three toroidal sets. However, those located where the strike-point used to reside

the most during high power operation are the most damaged, as are those in the toroidal position where electron collection was performed. Here two effects combine: the probe surface angle is steeper than that of the lamella and the power is enhanced by drawing electron current. Both these drivers for damage can be addressed, respectively by redesigning the probes and by limiting the voltage bias in operation.

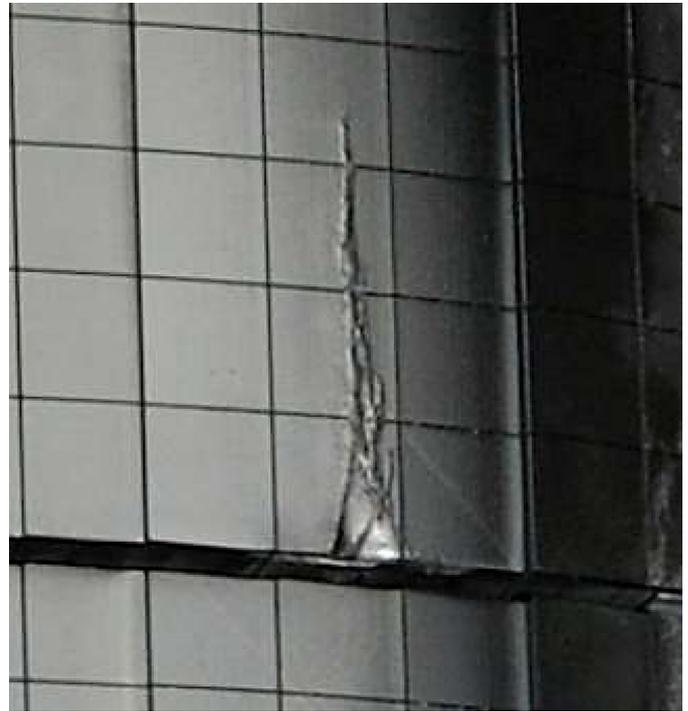
**Fig. 6.** Langmuir probe on the inner wall guard limiter and damage on the neighboring beryllium tile.

Also some of the main chamber Langmuir probes had power handling issues. Fig. 6 shows the top probe on the inner wall. Here, while the probe seems to have survived, the neighboring tile has been damaged. Like in the melting caused by the power handling experiments, the molten material has moved against gravity, indicating that some charge collection must have been preset. However, the cause of the melting is unclear. Even if the probes came into contact with the beryllium, heat transfer is very poor. As the Langmuir probe is very thin, it should have the same temperature both sides excluding radiation as cause of damage.
