JET exhaust detritiation system replacement—design, commissioning, and operation

To cite this article: Robert George *et al* 2023 *Plasma Phys. Control. Fusion* **65** 064002

¹ H3AT Division, UKAEA, Abingdon, United Kingdom

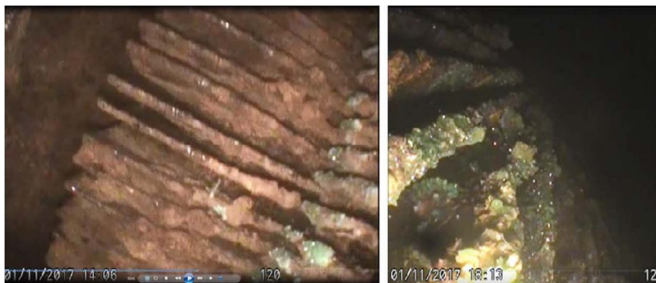
Figure 2. Internal inspection pictures of cooler/condensers' heat exchanger surfaces.

Figure 2 is a typical image exhibiting clear indications of corrosion on heat exchanger surfaces. The surfaces themselves were heavily contaminated with debris build-up, corrosion products and crystallised salts. Some surfaces also appeared wet, suggesting deliquescence due to salts present on the internal surfaces.

As a result of the extensive corrosion observed, the decision made was that EDS repair was not viable. Instead the entire system (up to but excluding the ADT) has been replaced.

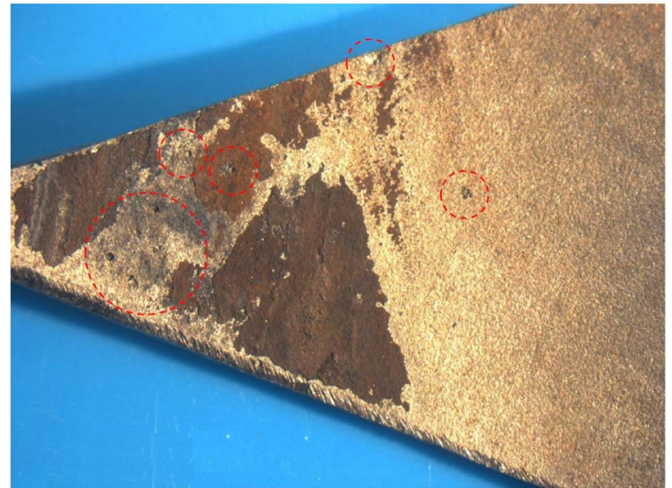
Figure 3. Section of pipework with pitting revealed after partial removal of surface deposits.

From figure 3, the colour of the deposit is indicative of iron-based corrosion product (haematite) but the structure of the deposits does not match a corrosion scale growth (e.g. from general corrosion); the 'mud-cracking' feature indicates deposition of fine particles from a liquid. Removal of the deposits revealed substantial pitting and indications of intergranular attack.

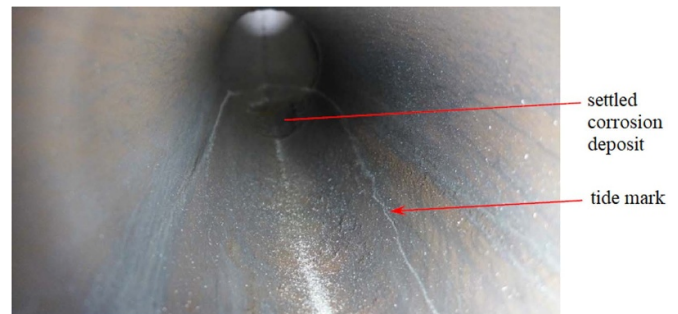
Figure 4. Internal image of 5 inch pipe demonstrating settled deposits and the presence of a tide mark.

Figure 4 shows 5" horizontal pipework with tide marks indicating build up of water in the bottom of the line whilst the top of the pipe is in better condition.

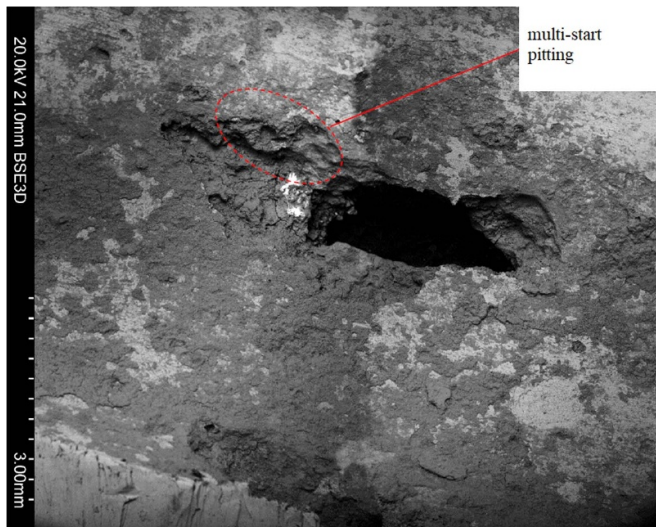
Figure 5. Scanning electron micrograph of perforation (location of pipe failure).

3.3.3. Discussion. Figure 5 is a SEM image of the hole in the 1/2” condensate pipe caused by pitting corrosion, this pitting was initiated by deposits of corrosion products, that were not solely generated locally to the hole. These formed occluded corrosion cells where localised anodic corrosion

sites experienced stabilised auto-catalytic pitting. Localised thinning in this location was covered by further deposits suggesting an extended operational period following the failure. Figure 6 shows further evidence of pitting corrosion.

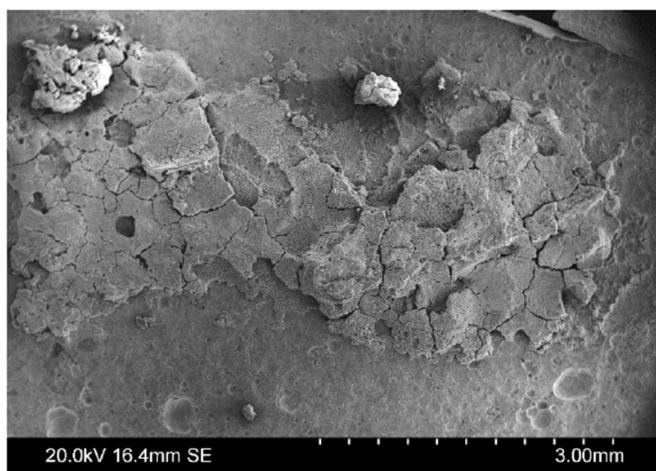
Figure 6. Pitting revealed on sample surface after partial removal of surface deposits using Clarke’s solution.

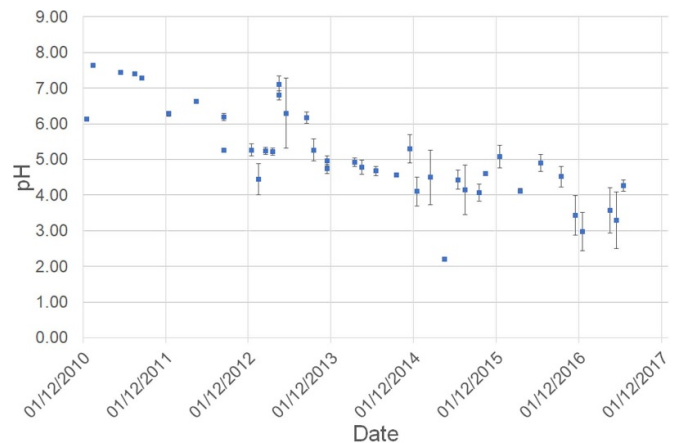
Figure 7. Averaged pH levels from active drain tank samples 2011–2017, including standard deviations.

3.4.3. Discussion. Routine liquid sampling (figure 7) has demonstrated a pH as low as 2; upon plotting the data, it can be seen pH has slowly reduced over the years from reading around 6.5 in 2011 to around 3.5 in 2017, at which time EDS failure occurred.

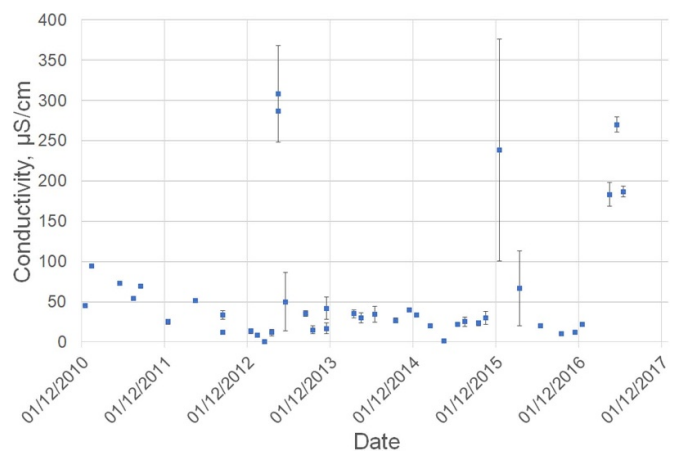
Figure 8. Averaged conductivity from active drain tank samples 2011–2017, including standard errors.

The liquid sample conductivity (figure 8) was relatively stable over time, but with at least one contamination event in 2013, and with an additional anomaly in December 2015, likely associated with the installation of the WDS. An order of magnitude increase is observed from April 2017.

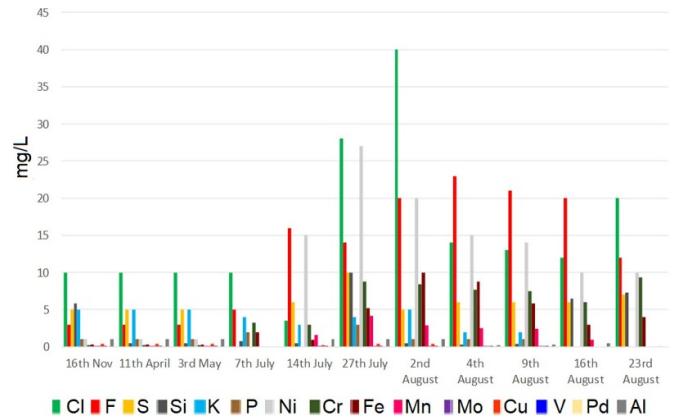
Figure 12. Ion concentration in the active drain tank.

3.6.3. Discussion. Elemental and ionic analysis of ADT water is shown in figure 12. The Cl levels after passing through the AGHS are at 10 mg l^{-1} from the 16 November to 7 July. There is also 2 mg l^{-1} of fluorine until the 7 of July where it doubles to 5 mg l^{-1} , corresponding to an increase in Cr and Fe. The 14 July sample shows a decrease in Cl but a rise in F and Ni also increases. From 27 July sample other components associated with 316 stainless steel construction (Fe, Cr, Mn) also rise correspondingly. The data shows the evolution of halogen ingress and corrosion with time, with increased amount of corrosion product reaching the ADT by 27 July.

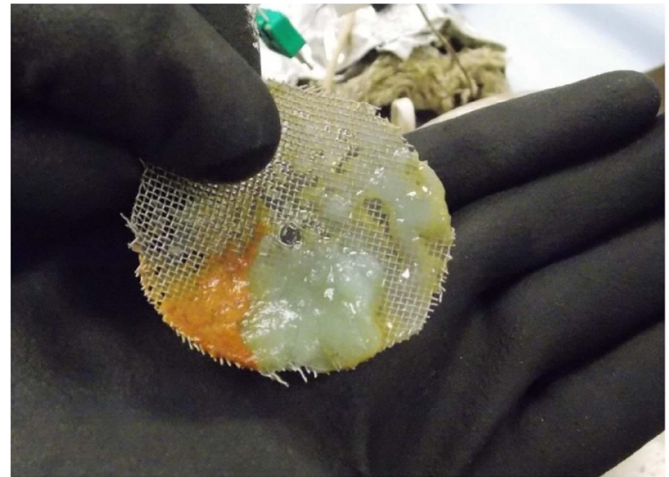
Figure 14. Gel deposit on test column diaphragm produced during acute HF testing Intersorb.

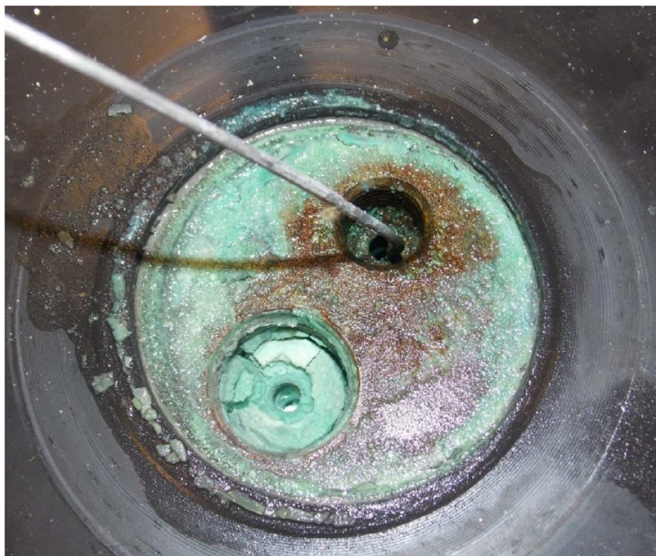
Figure 15. Corrosion product build-up on bottom flange and inlet pipework during acute HF testing Intersorb (note larger penetration was not used).

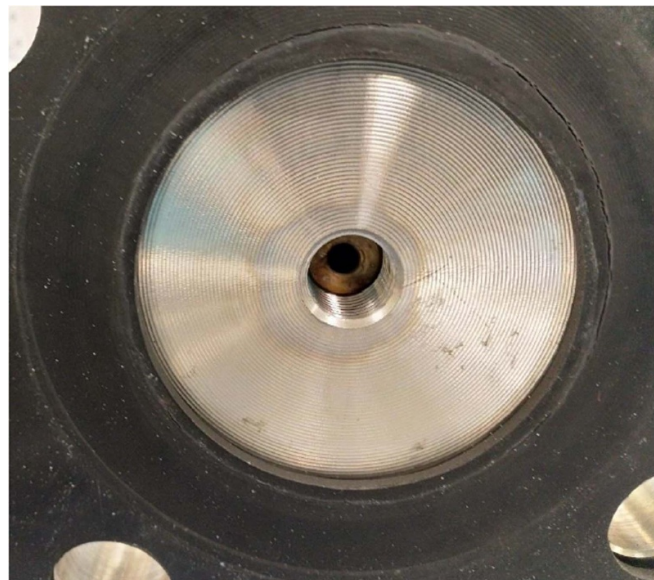
Figure 17. Light pitting corrosion on outlet flange during acute HF testing Intersorb.

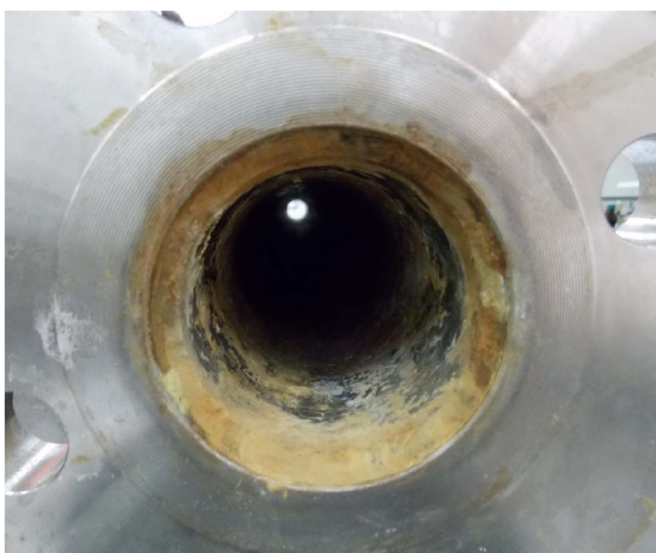
Figure 16. Corrosion within the inlet of the test rig column during acute HF testing Intersorb.

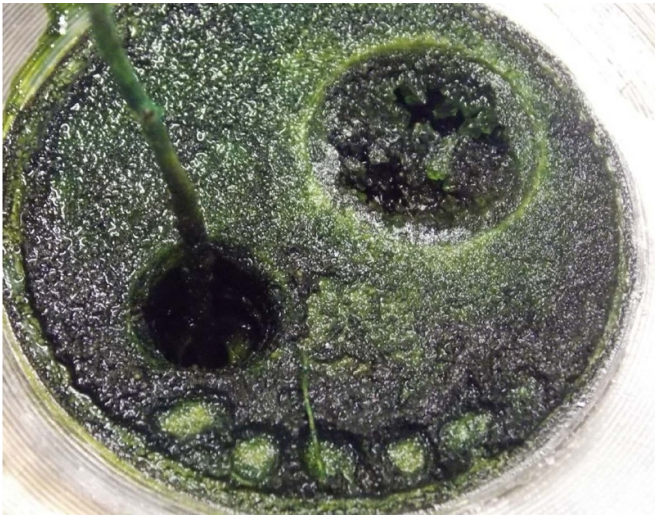
Figure 19. Green residue build-up on bottom flange following chronic HCl testing of Verdal.

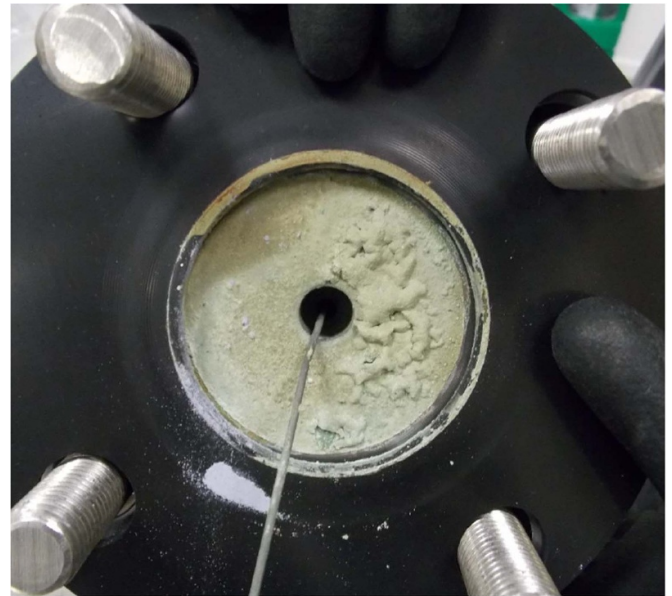
Figure 21. Thin layer of deposit on bottom flange following chronic HF/HCl mix test with Loflosorb.

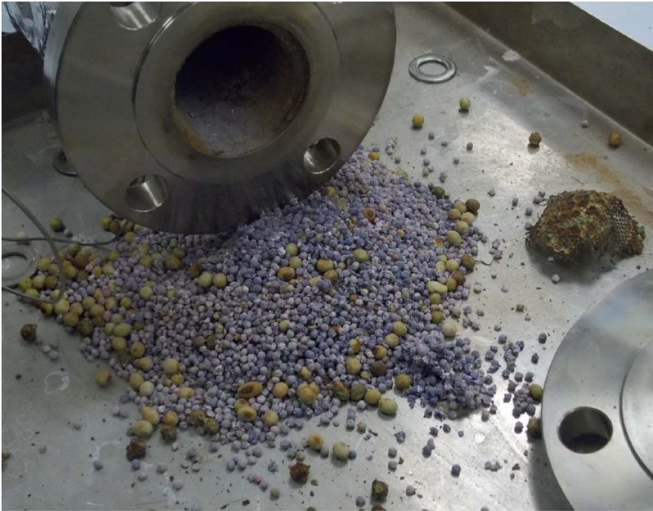
Whilst corrosion deposit was observed at the column inlet, the Loflosorb itself was in good condition (figure 23). No

Figure 23. Following accelerated chronic testing, Loflosorb (purple balls) came out in good condition.

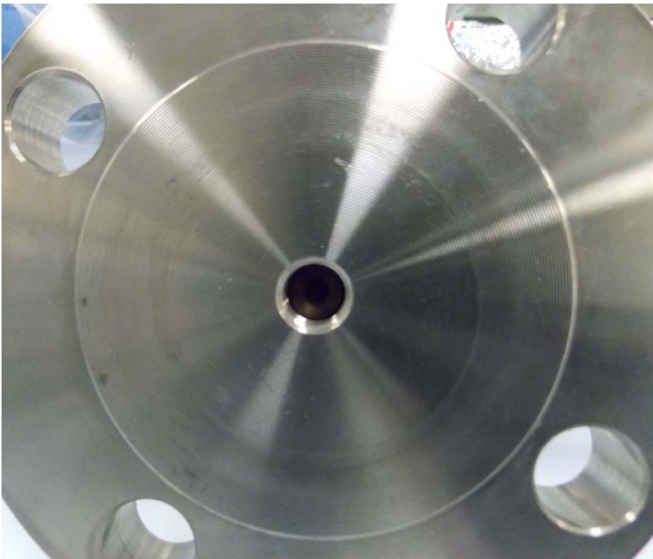
corrosion was observed at the column outlet (figure 24) and no breakthrough acid detected in the bubblers. The result of two week and three week tests were consistent. The three week test ultimately had equivalent of 14.6 months chronic acid loading.

Figure 24. Following accelerated chronic testing of Loflosorb, outlet flange was clean and free from corrosion.

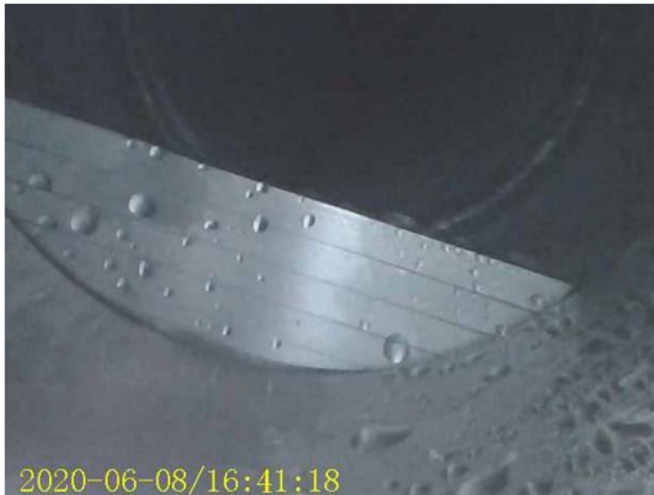
5.1.2. Condensate drain blockage. During initial proving of the condensate lines from one of the condensers to the CRT, water failed to drain properly. Investigation identified swarf or other small debris within the condensers had caused the blockage, compounded by a reduction in pipe internal diameter at the CRT interface (due to pressure vessel code compliance). The blockage was removed, equipment cleaned and

Figure 25. Condenser outlet camera showing the dam installed for Dryer 3. Water droplets and a pool forming can be seen during regeneration on 8 June 2020.

new strainers fitted on each drain line in order to prevent a recurrence.

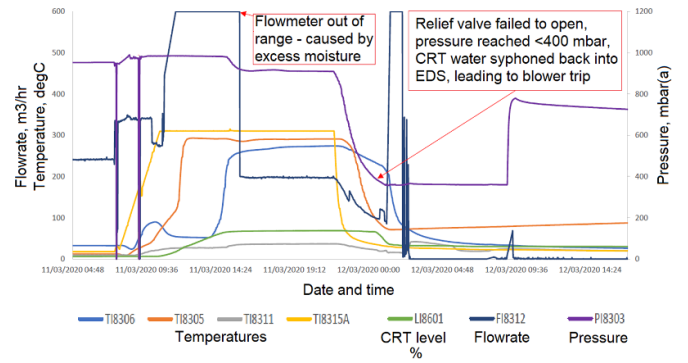
The valves were removed for inspection and confirmed to require higher differential pressure than specified to open. Half of the valves have been replaced with valves with metal to metal seats, and all were recalibrated with lower opening differential pressures. Software modifications were also made to

Figure 26. Dryer 3 regeneration: ingress of water from condensate relay tank, 12 March 2020.

close the condenser drain valve during regen cooldown or if pressure <600 mbar(a) is detected in the dryer circuit. No similar incidents have occurred.
