Overview of damage to beryllium limiters by unmitigated disruptions and runaway electrons in the JET tokamak with metal walls

To cite this article: I. Jezu *et al* 2024 *Nucl. Fusion* **64** 106047

Keywords: JET, beryllium, plasma disruptions, runaway electrons, material damage

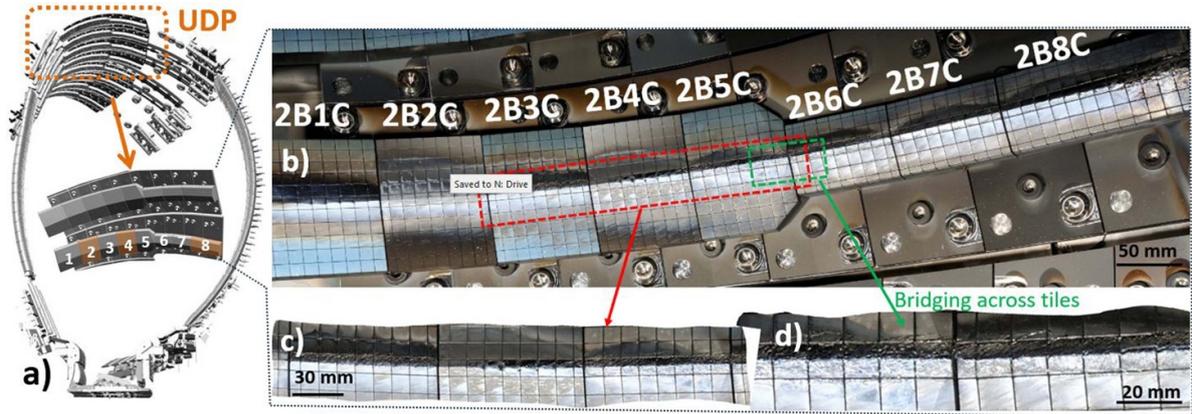
Figure 1. Cross section of JET vessel with a focus on the UDP sector (a) with in-vessel images of 2BC dump plate beam (b) which was partially removed (DP1 to DP5) for weighing exercise during intervention after second and third ILW campaigns, and close-up image (c) and (d) showing Be layer movement across DP3 and DP6.

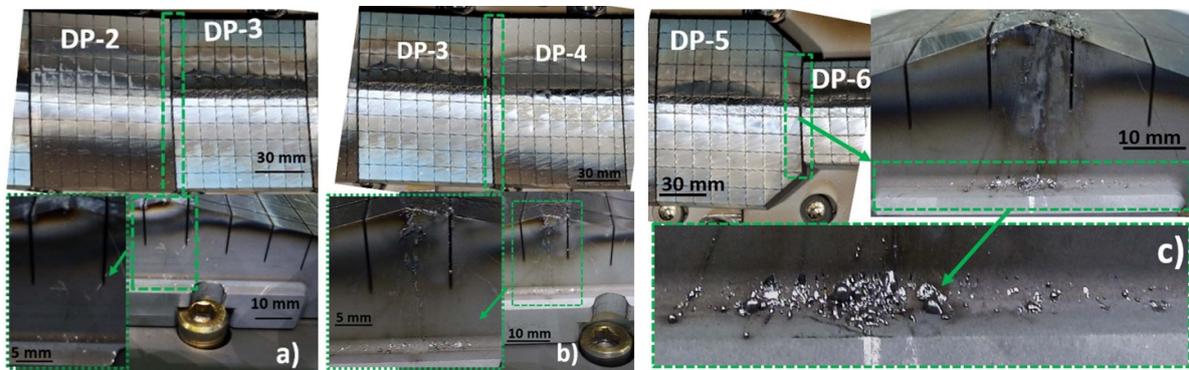
Figure 2. Photographs of dump plate tiles with close-up views showing beryllium droplets found in the gaps between tiles. (a) DP2 and DP3; (b) DP3 and DP4 and (c) DP5 and DP6 where most Be droplets were found.

An additional photographic survey was conducted on the entire beam of tiles of the UDPs. The results of the survey show new evidence that molten material can travel sufficient distances to potentially create bridges between adjacent tiles. Figure 1(a) highlights the cross section of JET vessel with the focus on the UDP sector. Detailed evidence of Be melt layer movement and castellation bridging is highlighted in figures 1(b)–(d) for tiles DP3 to DP6. One can observe an enhancement of the melt layer movement, towards the low field side generated by the $\mathbf{j} \times \mathbf{B}$ forces in the poloidal direction. Tile bridging is also observed towards the low field side. However, due to the larger gaps between tiles, some Be droplets were found in between the tiles. Small amounts of Be droplets can be seen on the DP2 tile, they are shown in figure 2(a). The amount of Be discovered in the form of droplets is reduced relative to the other tiles because this tile is replaced with a brand new one following each operational campaign in the metallic wall configuration. Therefore, the damage on it results from a single campaign, not from all three. More droplets are evident between tiles DP3 and DP4 in figure 2(b), and even more between tiles DP5 and DP6,

as shown in figure 2(c). In both locations, many Be droplets of various sizes can be seen in the spaces clearly indicating that layer migration occurs. In addition, bridging across castellation previously reported within a single tile, is also observed across neighbouring tiles despite the larger gaps. A significant number of resolidified beryllium droplets has been found in gaps between DP tiles towards the low field side. This shows that long range pathways for the gradual migration of melted material from the high field side to the low field side of the UDP beam is possible although some evidence of bridging between tiles may have been lost during the tile removal actions necessary during inter-campaign interventions. It is quite likely that molten Be material migrates from one tile to another once a bridge between tiles is built, but only if the gap between tiles is not too large to prevent such bridging. Based on the current imaging assessment it was shown that more melt in the form of resolidified droplets is found towards the low field side in the gaps of each tile. At this stage, there is no clear evidence that material mobilized from the high field side of the UDP beam, namely DP1, can travel as far as to the low field side, namely on the DP8. However, it is highly likely for this to happen in designs where gaps between tiles are smaller towards the low field side.

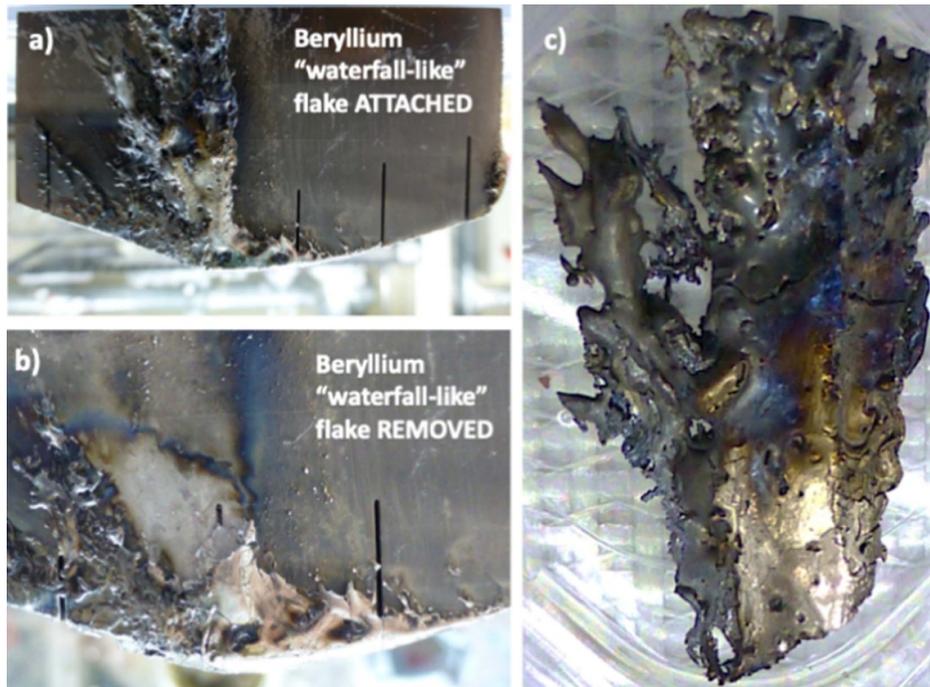
Figure 3. (a) Photograph of Be inverted ‘waterfall’ structure at the end of DP8; (b) after the Be flake was removed—with evidence that melted and solidified Be is still attached on the main tile, along with multiple droplets in different shapes and sizes; (c) full view of the Be ‘waterfall’.

As reported in [2] and described in section 2 the low field side tile of each of the 64 beams of upper limiters is characterized by the presence of an inverted Be ‘waterfall’ formation as depicted in figures 3(a)–(c). This structure is formed when the molten layer travels upwards, defying gravity in the poloidal direction from the high field side (inner wall) towards the low field side (outer wall), which is clearly attributed to melted material migration and re-solidification primarily due to the electromagnetic forces acting on the melt layer during a typical plasma disruption. The effect was earlier found and explained for molten tungsten in TEXTOR [3].

These structures were created primarily during the second operation campaign between 2013–2014 which was dedicated to high power scenarios with energy confinement optimization and ITER-relevant studies such as disruption mitigation by massive gas injection (MGI) [10]. Using a precision balance, the mass of the Be ‘waterfall’ structure was determined to 0.66 grams. Extrapolating to all 64 UDP beams, a total mass of 42 g was partially removed from the DPs, the value being of the same order of magnitude as the mass reported in [2]. The main point is that the $\mathbf{j} \times \mathbf{B}$ forces responsible for the Be molten layer movement across the DP tiles in poloidal direction was capable of mass dislocation in the range of 42 g for the entire JET vessel. Figure 3 along with the Be flake mass determination highlights again that Be melting, and layer movement is the main mechanism through which Be was lost from the UDPs.

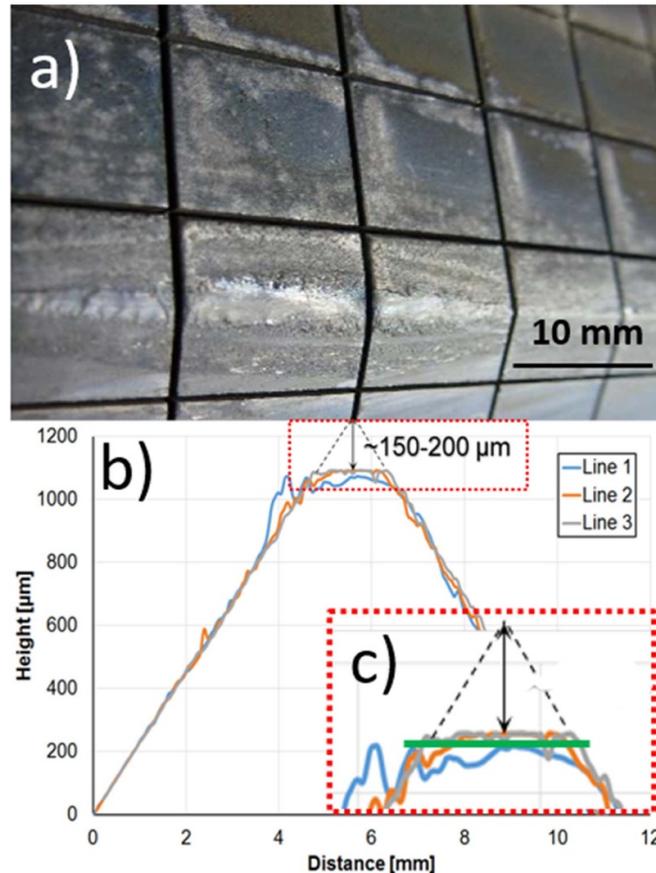
A DP2 tile was removed after each experimental campaign and replaced with a new tile before the start of the next campaign, so that the accurate mass loss quantification from the tile could be performed [2]. The damage was not as obvious as that

for the tile neighbouring it, namely DP1 and DP3, since DP2 was exposed only during a single campaign. However, the melt damage and crack formation on the DP2 tiles from both experimental campaigns (2011–2012 and 2013–2014) was documented in [11] and profiling measurements of each DP2 tile before and after (figure 4(a)) the campaign was performed. The study estimated $\sim 150\text{--}200\ \mu\text{m}$ of material thickness was removed from the top apex of the tile after the second campaign (figures 4(b) and (c)). Extrapolation for the entire tile indicates that around 0.035 g of Be was lost. Further extrapolation for all the UDP tiles across the 64 UDP beams in the JET vessel would account for $\sim 18.2\ \text{g}$ of Be loss—which can be considered as the minimum amount (lower limit) of Be material lost from the UDP. In comparison, the weighing exercise performed in [2] reported $\sim 1\ \text{g}$ of Be lost for the DP2 tile, with an estimation of 129 g from the entire UDP set-up. It is stressed that the minimum value of $\sim 18.2\ \text{g}$ estimated by profiling, considers measurements of only 2 mm in length in the toroidal direction on the top edge castellation (figure 4) of DP2 tile after the second operational campaign, while the damage to it was extrapolated for the entire UDPs. These methods are representative for the lower and upper estimations of mass loss in the UDP tiles due to high heat loads during unmitigated plasma disruptions based on the available data and extrapolation assumptions.

Figure 4. (a) Photograph showing close-up view of damage to the high field side DP2 tile, (b)–(c) estimation of material loss via profiling analysis in the range of $\sim 150\text{--}200\ \mu\text{m}$ in thickness.

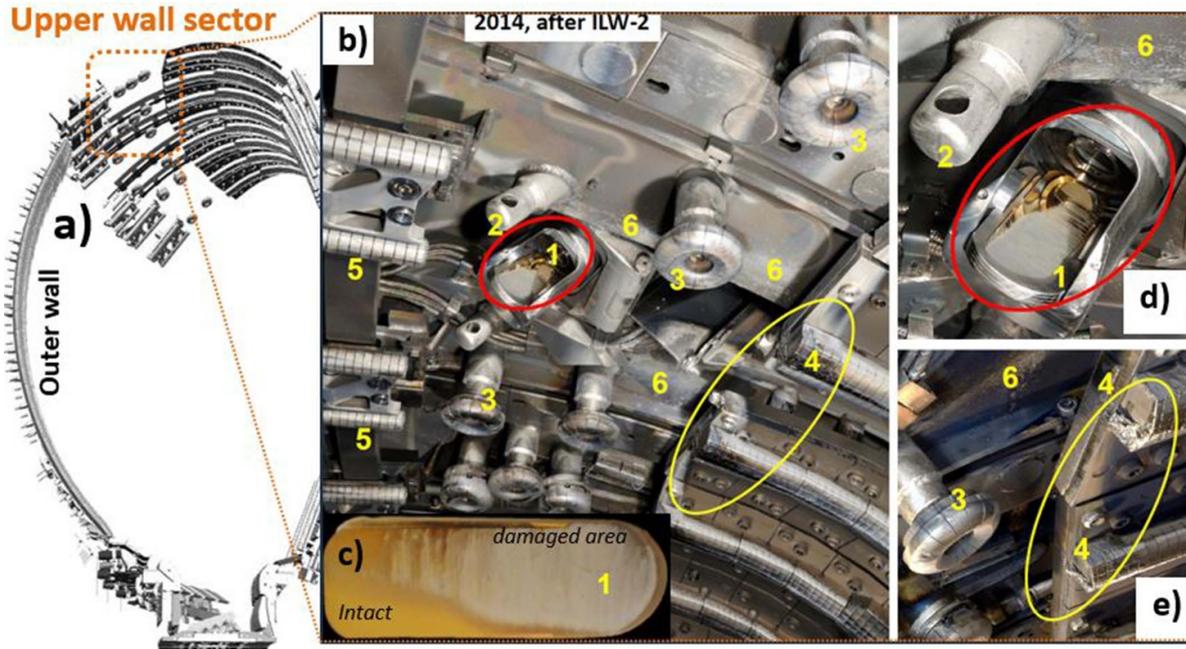
Figure 5. (a)–(e) View of the general location structure and details of the JET-ILW upper wall with respective elements indicated by numbers: the mirror (1), crane rail boss for fixing remote handling (RH) equipment (2) and beryllium PFCs: ML (3), UPD (4) and other, so-called sausage limiters (5). Areas with splashed Be are also marked (6).

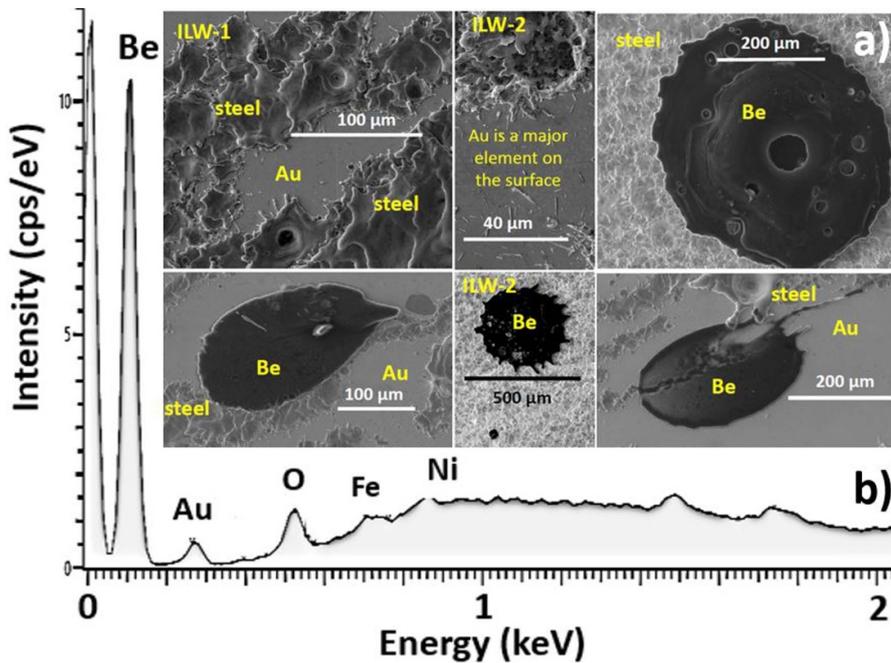
A number of SEM images in figure 6 show the mirror surface in the damaged area where arcing caused melting and melt layer motion. There are also Be splashes ranging in size ($200\text{--}400\ \mu\text{m}$) with diverse shape and structure displaying cracks or holes which may indicate boiling in the solidifying metal splash, e.g. figure 5(d). Clear images of the splashes in figure 6(a) and the strong Be $K\alpha$ line in the EDX spectra (figure 6(b)) suggest the absence of co-deposited species on the Be surface, thus indicating that the metal was ejected in the final stage of the second campaign when experiments with run-away electron generation were carried out.

Figure 6. (a) SEM images of Be splashes on the upper wall on KY6 gold coated mirror and (b) corresponding EDX spectra.

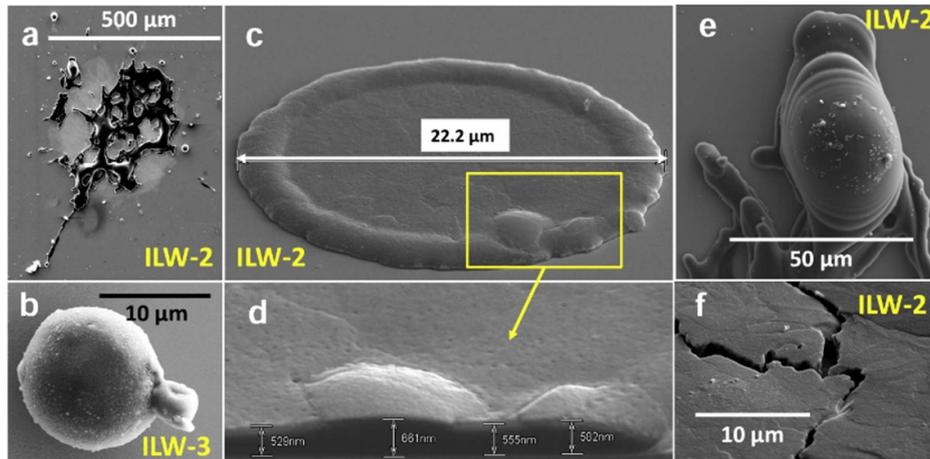
Figure 7. (a)–(f) Various forms of Be splashes found on the inner and outer wall dust monitors.

In-vessel high-resolution photographic survey carried out after each campaign has shown the presence of metal splashes on various wall components. It was not possible to carry out their elemental analysis, however, Be has been clearly identified as the main constituent of splashes on surfaces of mirror samples exposed at the outer wall midplane in JET within the first mirror test [14, 15]. Images in figures 7(a)–(f) show various forms of Be splashes and droplets on dust monitors from the inner and outer wall. Both their size and thickness vary within a broad range. In many cases these are flat circular (or only slightly elongated) objects with the thickness not exceeding several hundreds of nm, as shown in figures 7(c) and (d), and also described in [16, 17]. The presence of wrinkles resembling capillarity waves highlighted in figure 7(e) implies that the re-solidification of larger droplets ($50 \mu\text{m}$) did not occur instantaneously. Similar patterns have been previously identified during dust surveys in TEXTOR [18]. In some cases, the material was cracked, as in figure 7(f).

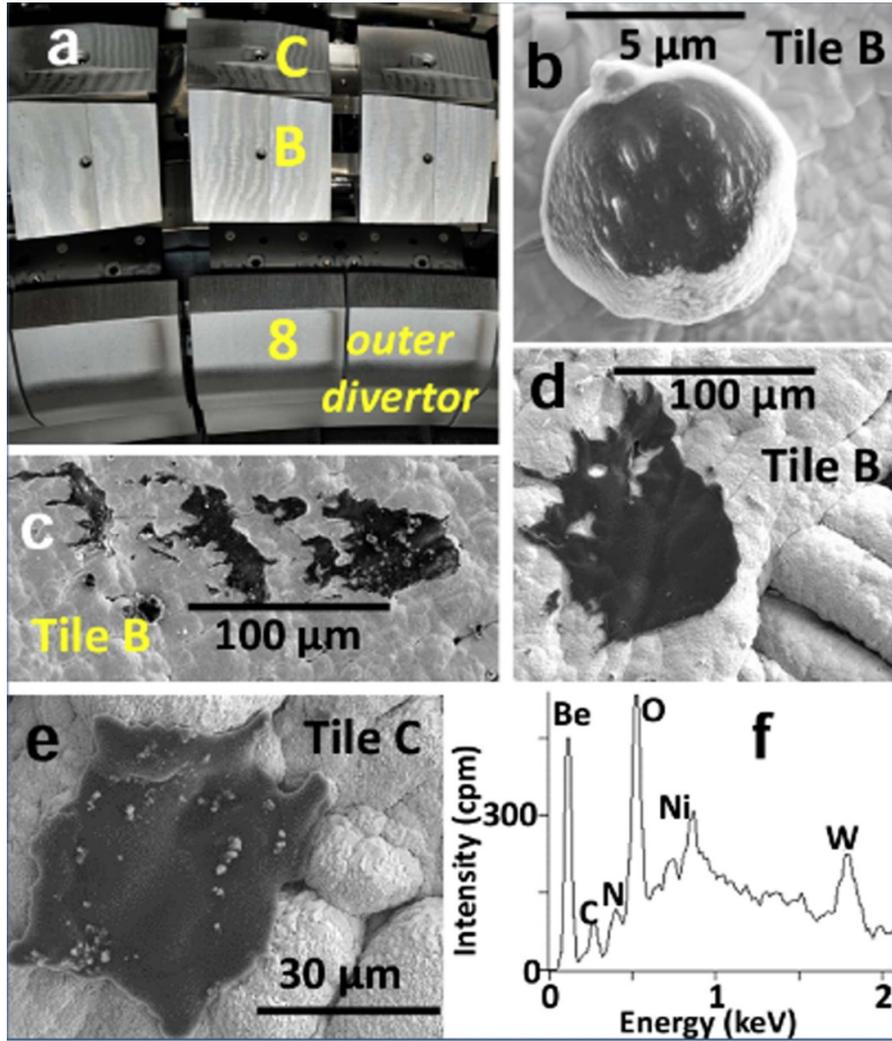
Microscopy examination of upper outer divertor Tiles 8, B and C has been carried out for the first time ever. The appearance of the tiles after ILW-3 is shown in figure 8(a), while other frames of that figure present a droplet and various shapes of beryllium splashes on the tungsten coating, figures 8(b)–(e) and an EDX spectrum with a clear Be feature, figure 8(f). Similar types of objects have also been found in samples collected on sticky pads from Tiles B and C. It should be noted that the splashes at the top of Tile 8 and protection Tiles B and C did not impact the plasma operations, as the outer strike point does not reach this region. As a consequence of minimal plasma interaction, Be analysis by EDX is possible because the splashes that collect there are not coated by co-deposits. Although there were many particles, they were quite small and covered a minimal area therefore the tile surfaces are still predominantly tungsten.

Figure 8. (a)–(e) Various forms of Be splashes found on the divertor tiles B and C and (f) the EDX spectrum with a clear Be feature.

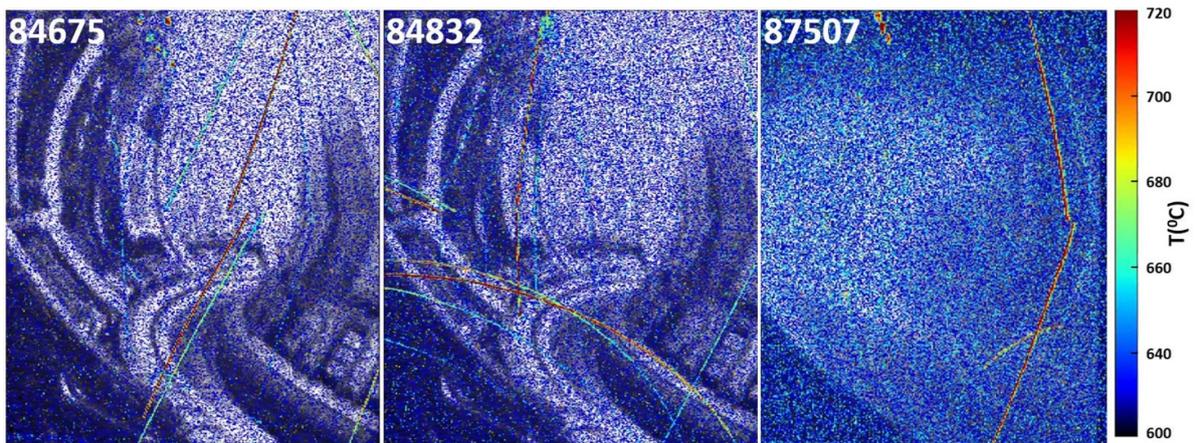
Figure 9. Post disruption Be ‘rain’ phenomena in three individual pulses as seen by the IR cameras.

toroidally). Figure 9 presents near-infrared photographic evidence of the thermal radiation emitted by heated Be droplets falling from the UDPs, captured with an exposure duration of 20 ms. Using another camera with a 600 μ s exposure time,

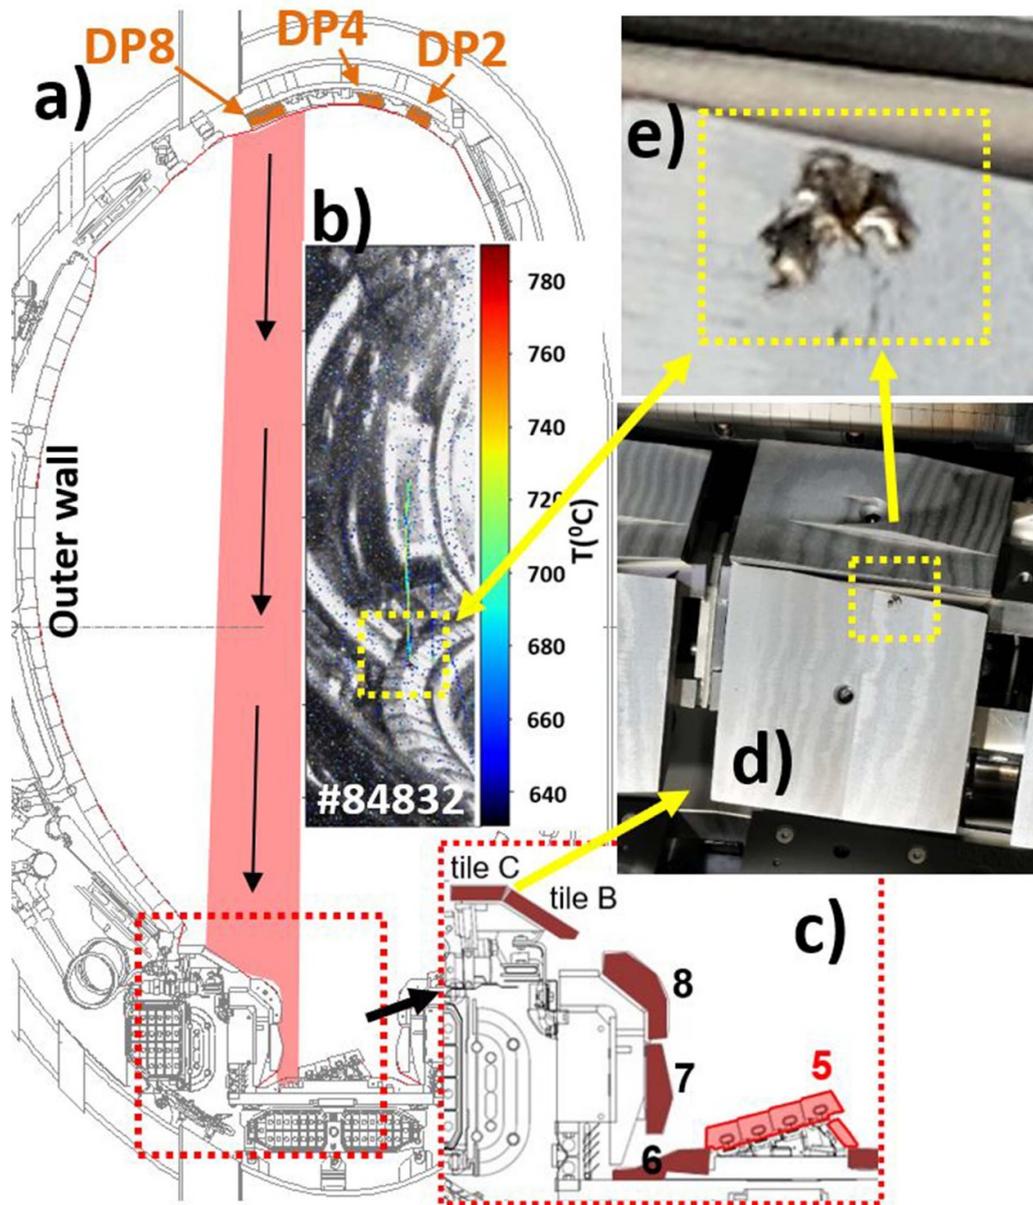
Figure 10. (a) JET cross-section with projection from the UDP to the possible location of Be ‘rain’ droplets once the magnetic field is off after a disruption; (b) near IR image post pulse no. #84832 highlighting the large droplet in the outer divertor; (c) a cross-section of the divertor with an indication to Tile B (d) and (e) a close-up view of the droplet found after the second campaign.

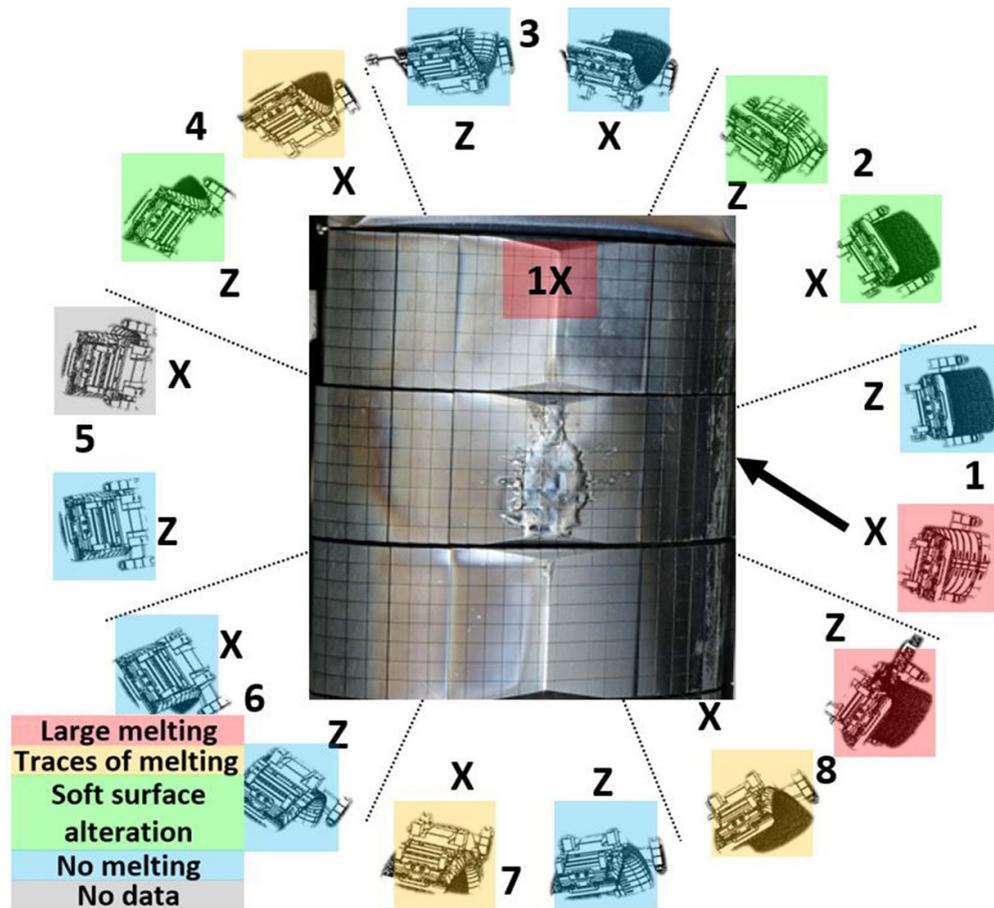
Figure 11. Toroidal distribution of the IWGL beams in JET reactor, with a photograph in the centre from the 1X beam showing localised damage from runaway electrons. The toroidally asymmetric damage due to the REs is highlighted by the colour map.

uniform. There are only two heavily affected tiles, namely on the 1X and 1Z inner limiter beams, while the rest have either no visible damage or only slight traces of it. The lack of uniformly distributed damage is also observed in poloidal direction, since the only affected tile from the 1X beam is the one shown in the centre of the image. A closer look to the damage feature was possible once the damage tile was removed during the 2017 intervention. In the following, morphological and structural analysis of this tile is presented.

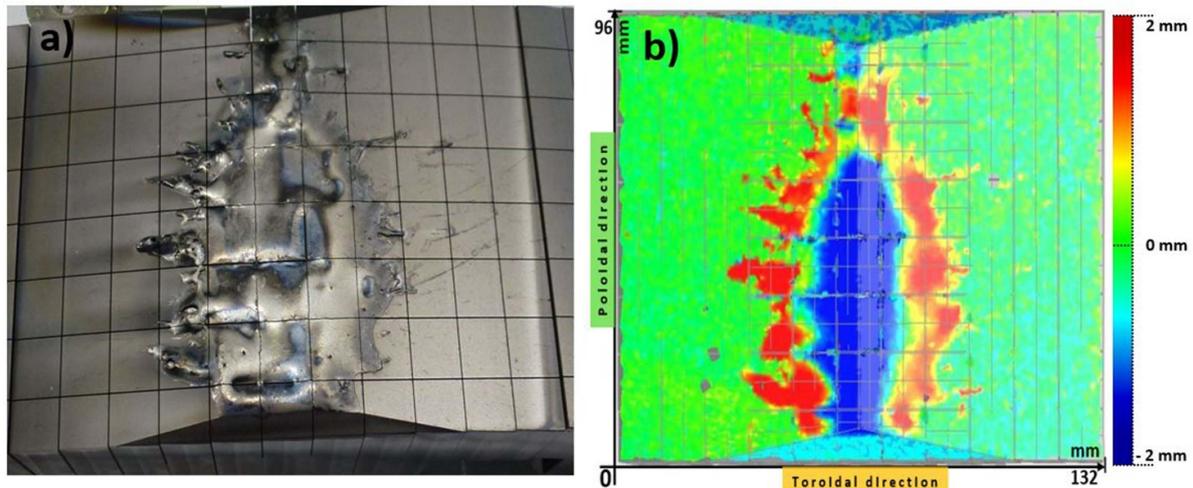
Figure 12(a) shows a high-resolution image of the affected tile once retrieved from the torus. To assess the magnitude of the damage, a 3D profiling measurement was conducted using a AL147 FARO Edge with AL148 laser line probe. These results were directly used for damage modelling purposes. Figure 12(b) is a colour map of the damaged tile surface, revealing the extent and distribution of the erosion induced by the REs. The generated profiling image in figure 12(b) is based on a comparison with a reference model of an undamaged tile. The colours correspond to different levels of deviation from the reference. The colour 'green' depicts no change as compared to the reference, meaning that the tile surface was unaffected. The 'blue' colour represents the points that were between 1–2 mm lower than the reference, highlighting damage in the form of 'pools' on the tile surface. These pools are the result of Be melting and evaporation due to extreme

Figure 12. (a) Photograph of RE damaged tile and (b) reconstructed damaged surface via tile 3D profiling.

heat induced by the runaways. The ‘red’ colour corresponds to points that were 1–2 mm above the reference revealing damage in the form of ‘hills’ on the tile surface. These protrusions to the tile surface are most likely the consequence of material displacements and re-solidification of Be after the tile was hit by the REs. The analysis shows that the RE impact caused considerable damage, but was focused on one tile only thus confirming previous statements that the REs impact was very localized without any major effect on the surrounding PFC.

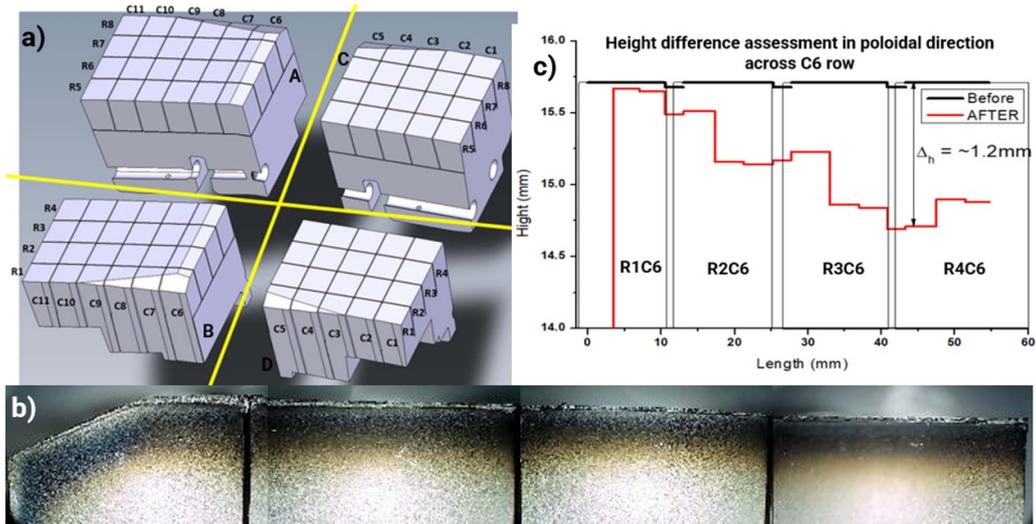
For a better assessment of the depth damage generated by the REs, the tile was cut in four quarters (figure 13(a)). Optical micrographs in figure 13(b) show the extent of the damage in the poloidal direction across four individual castellations. The images provide evidence of molten material bridging gaps between adjacent castellations, a similar behaviour as seen in [2]. However, no accumulation of molten material penetrating into the castellation grooves is observed. In line with the melt propagation mechanisms discussed in [6], this result is the first experimental evidence showing clearly the distinction between melting effect from REs and unmitigated disruptions. For the unmitigated disruptions, $\mathbf{j} \times \mathbf{B}$ forces arising from thermal electron emission in a magnetic field moved material in the poloidal direction filling partially the gaps. Whereas for REs, although there is a significant current, melting is deeper into the surface with no thermionic emission compensation current being generated to drive $\mathbf{j} \times \mathbf{B}$ forces and move the melt layer. In addition, any strong current flow resulting from the REs (disregarding the magnetic field’s influence on the electrons scattered within the material) is predominantly parallel to the toroidal field, thus not contributing to the $\mathbf{j} \times \mathbf{B}$ drive [6]. Therefore, the castellation gaps are not filled by RE melting, as shown here. Measurements revealed a difference in height of material displacement of 1.2 mm for the measured section (figure 13(c)),

Figure 13. (a) View of split tile with (b) optical microscopy in the poloidal direction showing close-up view of melting at the surface and (c) height difference measured in the poloidal direction.

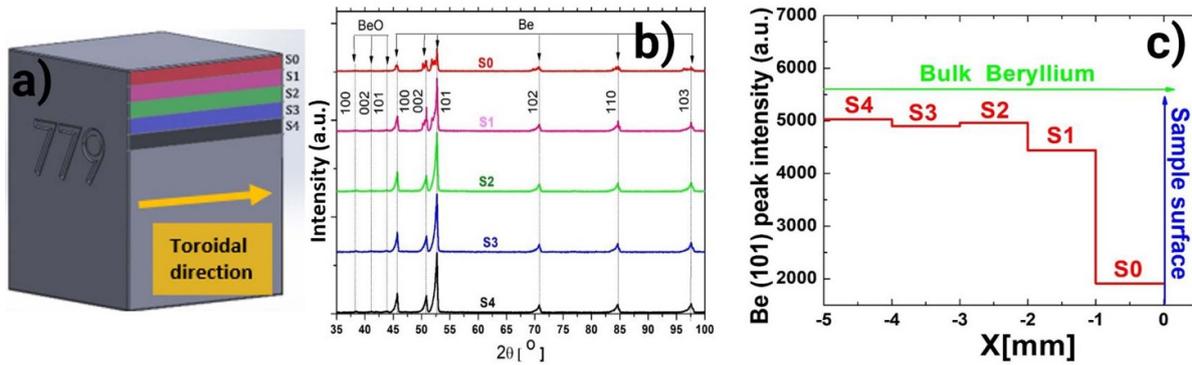
Figure 14. (a) Representation of x-ray measurement patterns; (b) diffraction patterns for all analysed regions; (c) comparison of Be 101 relative intensity.

surface region, the extinction of the Be 101 scattering centres by $\sim 60\%$ compared with the S2–S4 areas and a peak broadening suggests a transition to an amorphous state of Be near the surface. The overall measurement was performed using a Rigaku Ultima IV diffractometer using a Cu-K α radiation source (0.154 nm) and a D/teX Ultra 1D silicon strip detector with a graphite monochromator. Measurements were done in the θ – 2θ geometry ranging from 33° to 100° with a step of 0.05° .

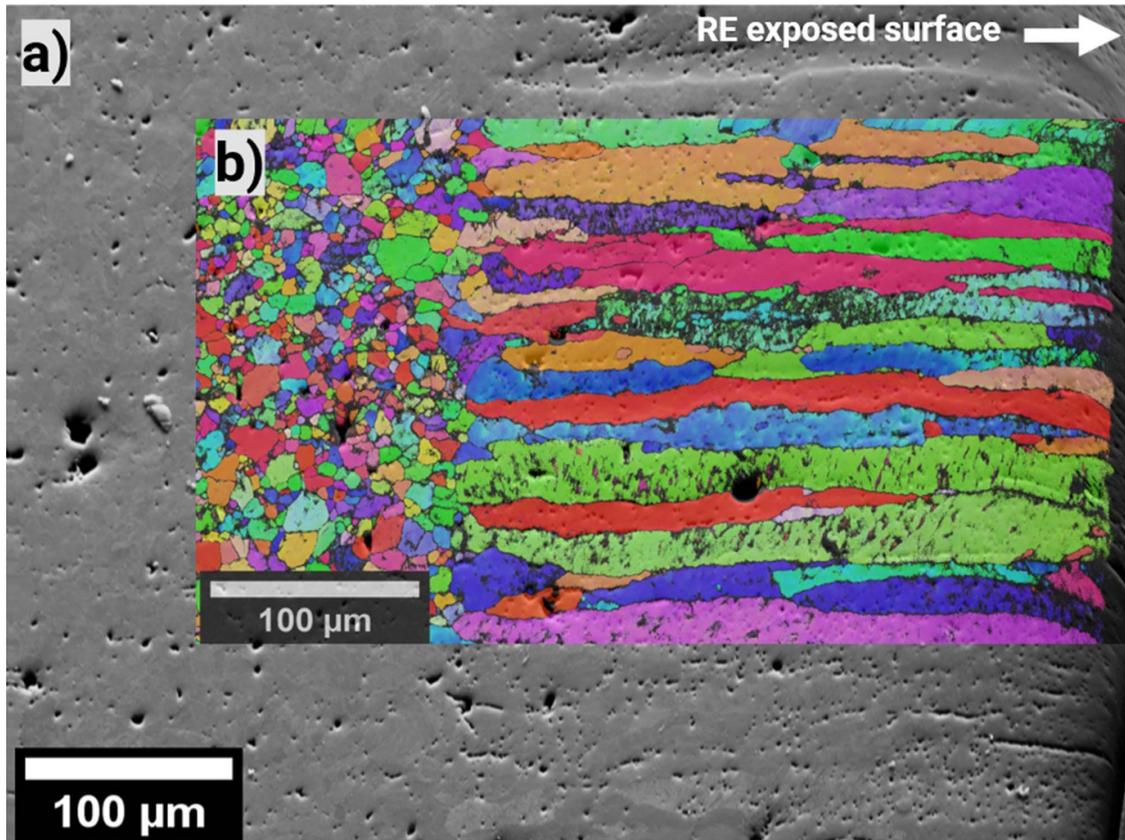
Electron backscattering diffraction (EBSD) combined with Scanning Electron Microscopy (SEM) were performed to visualize the topography and crystallographic structure of the RE damaged region. Figure 15(a) depicts the secondary electron image of the analysed castellation. The right side is the plasma facing surface affected by the REs, while figure 15(b) highlights the surface normal-projected inverse pole figure orientation map of the near-surface region of the plasma-affected Be. The results demonstrate that material melted and then re-solidified in the 330 μm thick near surface region. The re-solidified phase has columnar grain structure

with a long grains perpendicular to the exposed surface. The lengths of these grains often equal to the depth of the melted-resolidified layer. In the area deeper than the melted layer, the base material has uniaxial grains (avg. diameter $< 10 \mu\text{m}$) typically observed in vacuum hot-pressed beryllium grades [26]. Many non-cubic metals including beryllium have strong anisotropy of thermal expansion, therefore can be deformed by heating and cooling. During cooling of a polycrystalline Be, its anisotropy leads to development of a compressive internal stress along the $\langle c \rangle$ axis of grains and a tensile stress along the $\langle a \rangle$ axis of grains. At high temperatures these intergranular stresses may relax by material deformation introducing dislocations and micro-twins and also creation of microvoids. The micro-twins and degradation in the EBSD pattern quality, which are a sign of a higher dislocation density have been detected in the resolidified grains. Microvoids were observed both in as received and re-solidified materials. However, visually, more voids were observed in the melted areas with occasional lineal agglomeration around grain boundaries.

Figure 15. (a) Secondary electron image of the REs damaged region with a focus on the (b) inverse pole figure orientation map.
