Global erosion and deposition patterns in JET with the ITER-like wall

A set of Be and W tiles removed after the first ITER-like wall campaigns (JET-ILW) from 2011 to 2012 has been analysed. The results indicate that the primary erosion site is in the main chamber (Be) as in previous carbon campaigns (JET-C). In particular the limiters tiles near the mid-plane are eroded probably during the limiter phases of discharges. W is found at low concentrations on all plasma-facing surfaces of the vessel indicating deposition via plasma transport initially from the W divertor and from main chamber W-coated tiles; there are also traces of Mo (used as an interlayer for these coatings). Deposited films in the inner divertor have a layered structure, and every layer is dominated by Be with some W and O content.

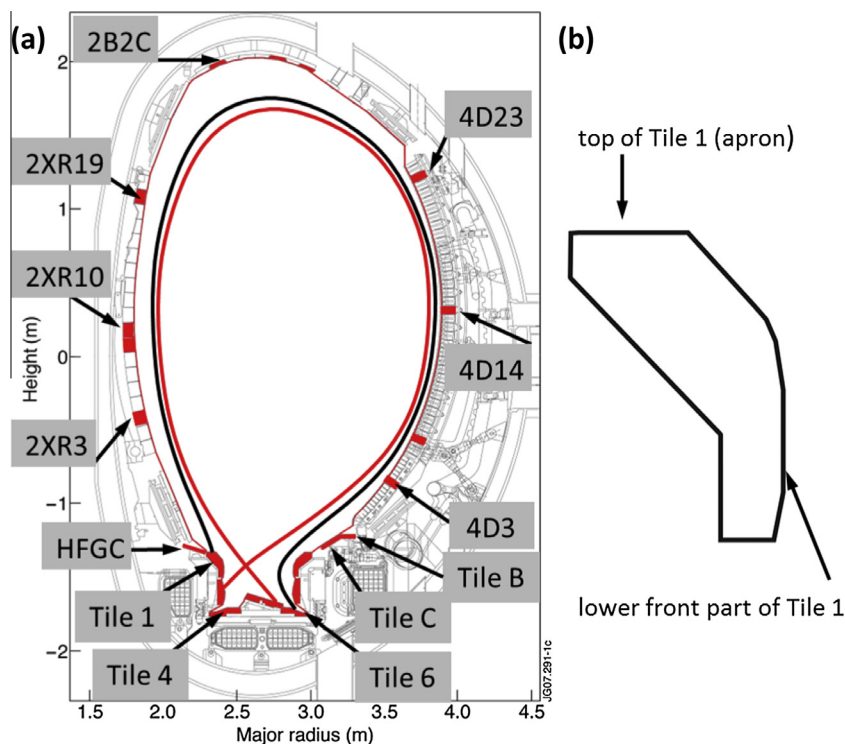
Fig. 1. (a) Poloidal cross-section of the JET vessel with the location of the investigated tiles indicated and (b) diagram of Tile 1 showing the regions referred to in the text.

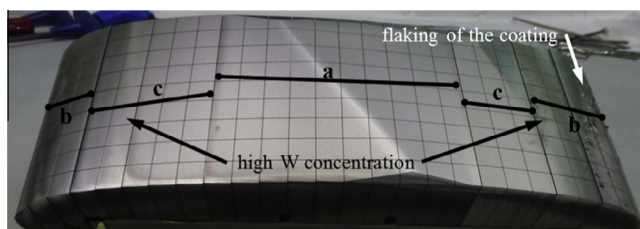
indicated (Fig. 1). Visual inspection of the OPL has been reported in [3,6]. At the centre of a tile near the midplane (4D14) the marker coating has been eroded and only bulk Be remains (Fig. 2, region a). Profilometry indicates erosion of a minimum of 10 μm . IBA shows re-deposition of Be and Ni onto both left and right sides (Fig. 2, region b). However, the right side of the tile is also characterized by some flaking of the coating, which limits the validity of the IBA analysis. Nevertheless based on IBA it can be concluded that where the coating remains it is a mixture of mainly Be with Ni and W. Between the eroded area and the ends of the tile are transition regions where the surface is virtually as the original marker layer (Fig. 2, region c). Overall the analyses indicate net erosion over the tile, which if it were the same extent for the middle plane Tile 14 of each of the 8 OPL in the vessel would amount to erosion of 5 g for just these tiles during the ILW campaign. Secondly, there is no indication from the RBS spectra of significant erosion or deposition on tiles 4D3 and 4D23 since the marker coating is still intact. The tiles are relatively clean, however there are traces of W, Ni, Mo, Cr, and Fe on the surface, and IBA shows some D retention. Finally, surface profilometry results confirm that any changes to the surface profile were below the detection limit ($\pm 5 \mu\text{m}$), so these tiles do not contribute anything to the net erosion/deposition in the vessel during the ILW.

Fig. 2. Photo of OPL (4D14) after ILW campaigns 2011–2 and the marker coating evaluation. A central erosion zone (indicated by a), a left and right wing deposition zone (indicated by b), and a middle part where the marker starts appearing (indicated by c). A region of flaking film is also indicated.

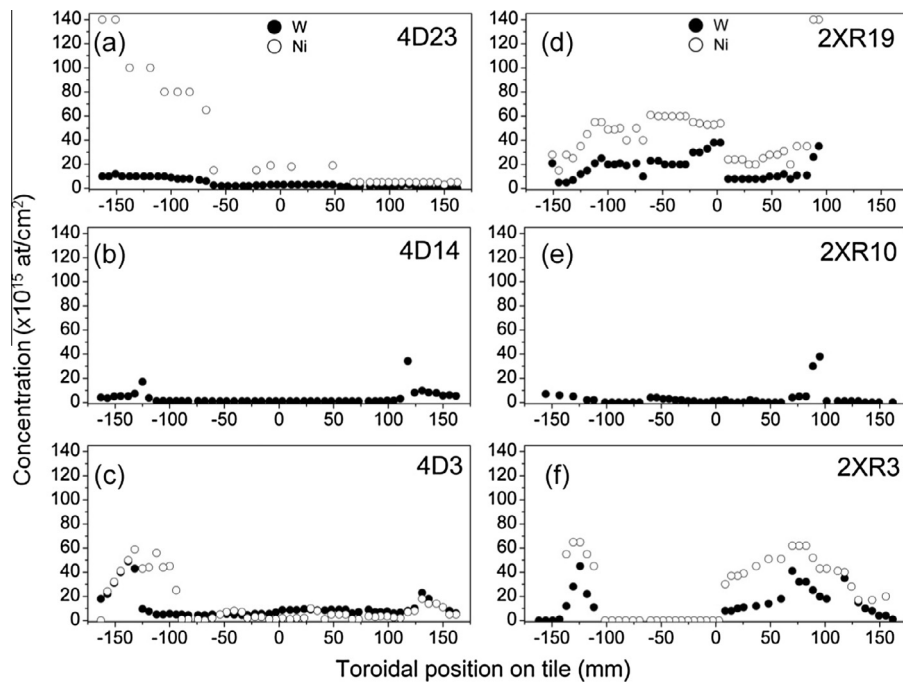
W and Ni impurities are present on all the tiles in the main chamber, but their concentrations can vary considerably as shown in the examples in Fig. 3; Ni distributions are only shown where it is clear the Ni is present as a deposited impurity and is separate from the Ni marker interlayer. The amounts of W, Ni and also traces of Fe, Cr, Ti and Mo were calculated by combining RBS and PIXE data, and the combined amount does not exceed 0.1% of the elemental composition of the deposit. W and Ni have been found on all three investigated OPL tiles, with a higher concentration on the left-hand side of 4D3 and 4D23 (Fig. 3a and c). Deposition of W and Ni has slightly different pattern for the 4D14 (Fig. 3b): In the central part of the tile the W concentration is below $1 \cdot 10^{15}$ at/cm² and reaches maximum of approximately $30 \cdot 10^{15}$ at/cm² at the location indicated by the arrows in Fig. 2. On the surface of the middle IWGL (2XR10) and the bottom (2XR3) (Fig. 3e and f, respectively), the W surface peak signal (accompanied by Ni surface signal, not related to the underlying marker) is greater on the right-hand side of the limiter, whereas the W concentration is higher on the left-hand side of the 2XR19 (Fig. 3d). Extensive melting along the poloidal ridge of the dump plate (DP) was found at all locations around the top of the machine and appears toroidally uniform in character. The melted ridge is closest to the plasma. Higher content of W has been found on the DP side where arc tracks are visible and is in the range from

5 to $40 \cdot 10^{15}$ at/cm² and Ni concentration varies from 20 to $50 \cdot 10^{15}$ at/cm².

Fig. 3. W and (in some cases) Ni impurity concentrations across the OPL and IWGL tiles analysed: (a) OPL Tile 4D23, (b) OPL Tile 4D14, (c) OPL Tile 4D3, (d) IWGL Tile 2XR19, (e) IWGL Tile 2XR10, (f) IWGL Tile 2XR3.

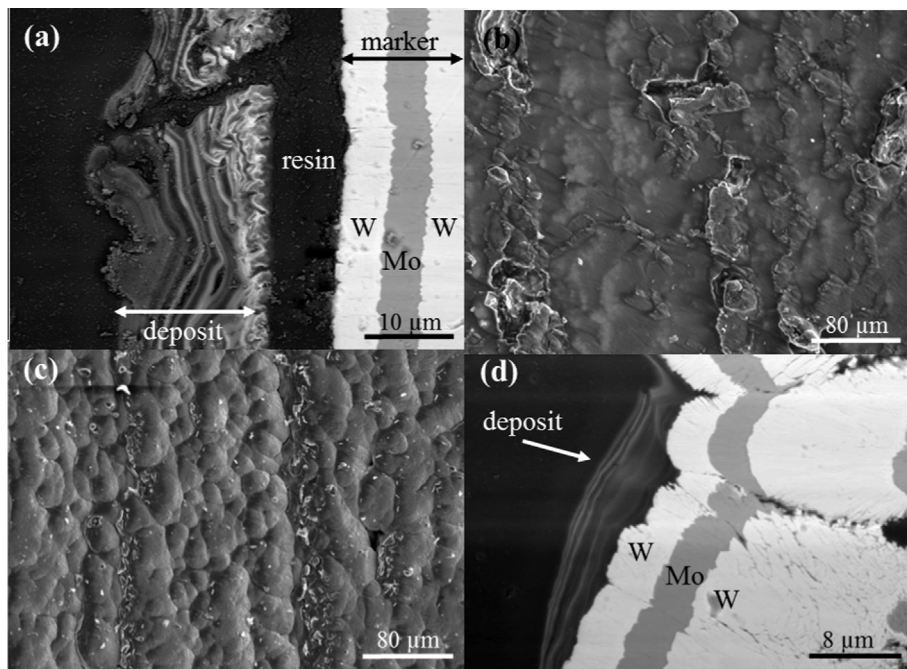
Fig. 4. (a) BSE image of a cross-section of the top part (apron) of Tile 1 (the deposited layer has separated from the tile surface during the mounting process), (b) BSE image of a top view of the of the Tile 1 apron surface, (c) BSE image of a top view of the Tile 4 surface with characteristic cauliflower morphology, and (d) BSE image of a cross-section of the sloped part of Tile 4 near the strike point showing deposit in the valleys.
