# Thirty year operational experience of the JET flywheel generators

Daniel Rendell\*, Stephen R. Shaw, Peter J. Pool,  
Colin Oberlin-Harris, JET EFDA Contributors<sup>1</sup>

JET-EFDA, Culham Science Centre, Abingdon, Oxon OX14 3DB, UK

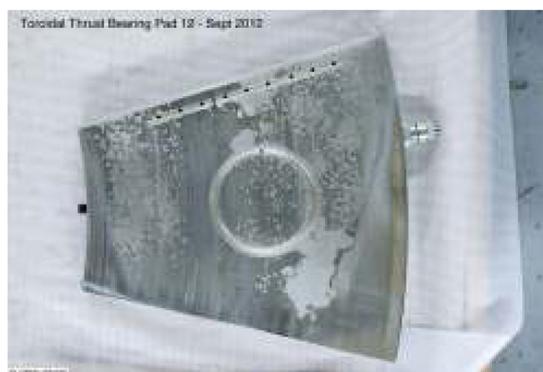
Fig. 1. Pad 12 removed from the TF generator in 2012.

Inspection of the TF generator's thrust bearing pads after it stuck for several weeks in 2011 showed an area of white metal that had melted on one pad, and evidence of rubbing between the running disc and the pad trailing corners (Fig. 1). This damaged pad set, as well as the set removed from the PF generator (Section 3.2.3) were refurbished using the available manufacturer's drawing and specification data.

It was concluded that it is desirable for the pads to have a “crowned” (spherical) profile at ambient temperature.

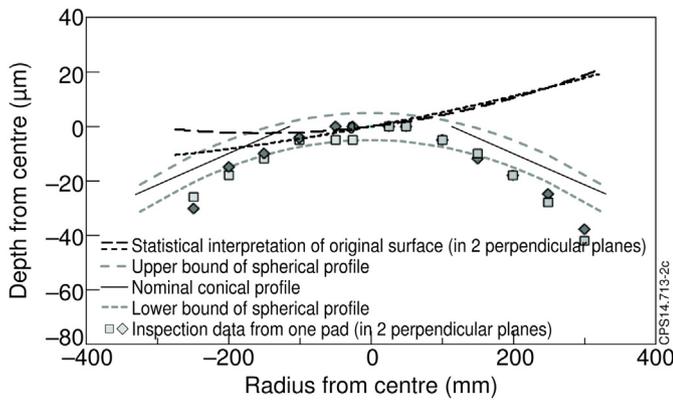
Fig. 2. A comparison of pad profiles before and after refurbishment process #1.

Fig. 2 compares the shape of one pad after conical machining with the generalised profile from before machining, and the target spherical profile.

For the second of pads which were reprofiled the same manufacturer proposed a simplified process intended to result in better dimensional control. In this, a single machining operation producing a truncated cone was followed by hand-lapping.

The set refurbished by cutting concentric rings has been refitted to TF generator. Commissioning tests gave acceptable results for break-out torque during manual test pulls which were an improvement over the pads which were known to be concave, and the machine has operated without apparent problem or any starting difficulty.
