Thirty Year Operational Experience of the JET Flywheel Generators

D. Rendell¹, S.R. Shaw¹, P.J. Pool¹, C. Oberlin-Harris¹, and JET EFDA Contributors^{*}

¹*JET-EFDA, Culham Science Centre, Abingdon, Oxon OX14 3DB, UK*

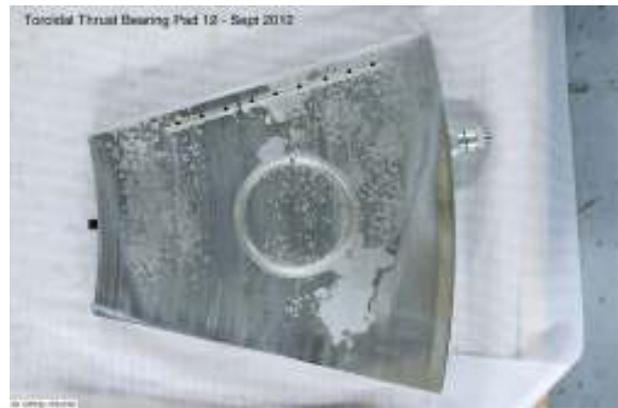
Inspection of the TF generator's thrust bearing pads after it stuck for several weeks in 2011 showed an area of white metal that had melted on one pad, and evidence of rubbing between the running disk and the pad trailing corners (figure 1). This damaged pad set, as well as the set removed from the PF generator (3.2.3) were refurbished using the available manufacturer's drawing and specification data.

that the white metal surface profile itself could be a major contributor to excessive friction.

Fig 1. Pad 12 removed from the TF generator in 2012

It was concluded that it is desirable for the pads to have a “crowned” (spherical) profile at ambient temperature.

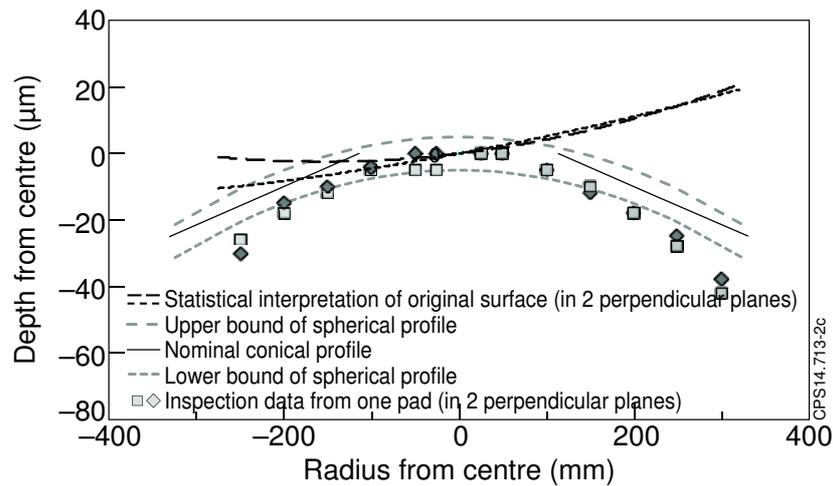
Fig.2 A comparison of pad profiles before and after refurbishment process #1

Figure 2 compares the shape of one pad after conical machining with the generalised profile from before machining, and the target spherical profile.

A process was developed in conjunction with a sub-contract supplier expert in the design and manufacture of white metal bearings. This attempted to produce a spherical profile by machining several concentric rings and hand-lapping. This process was applied to one set of pads, during which the pad-to-pad variation in the amount of white metal removed was greater than expected.

The set refurbished by cutting concentric rings has been refitted to TF generator. Commissioning tests gave acceptable results for break-out torque during manual test pulls which were an improvement over the pads which were known to be concave, and the machine has operated without apparent problem or any starting difficulty.
