Are tungsten-based nuclear fusion components truly invisible to x-ray inspection?

To cite this article: Triestino Minniti and Heather Lewtas 2022 *Nucl. Fusion* **62** 066003

UKAEA-United Kingdom Atomic Energy Authority, Culham Science Centre, Abingdon, OX14 3DB, United Kingdom of Great Britain and Northern Ireland

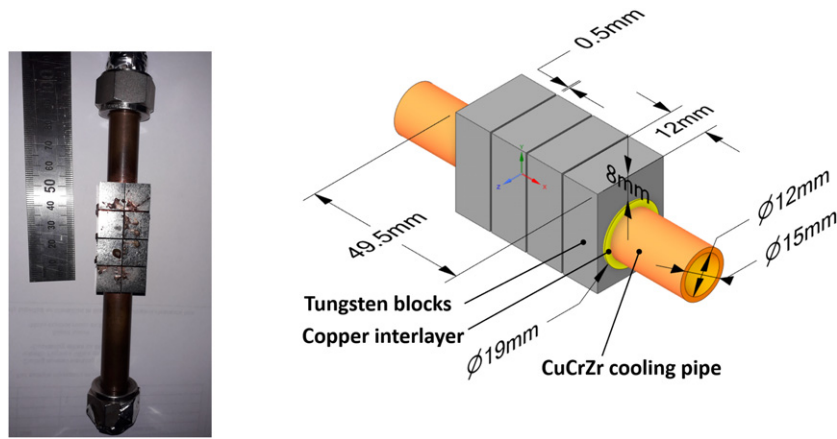
Figure 1. (Left panel) Photograph of the DEMO divertor target studied by means of 6 MeV energy XCT. (Right panel) A schematic drawing with the relevant dimensions of the sample.

to the component is clearly visible from the x – y and y – z cross-section images which have revealed multiple failures of the inner CuCrZr alloy pipe and the oxygen-free high conductivity (OFHC) copper interlayer. Damage to the component is particularly located in the proximity of the two central monoblocks. Melted materials caused by the HHF load have been partially deposited on the external W tile surface and they are visible in the 3D volume rendering image of the specimen in figure 3(d) as well as on the picture of the sample reported in the left panel of figure 1.

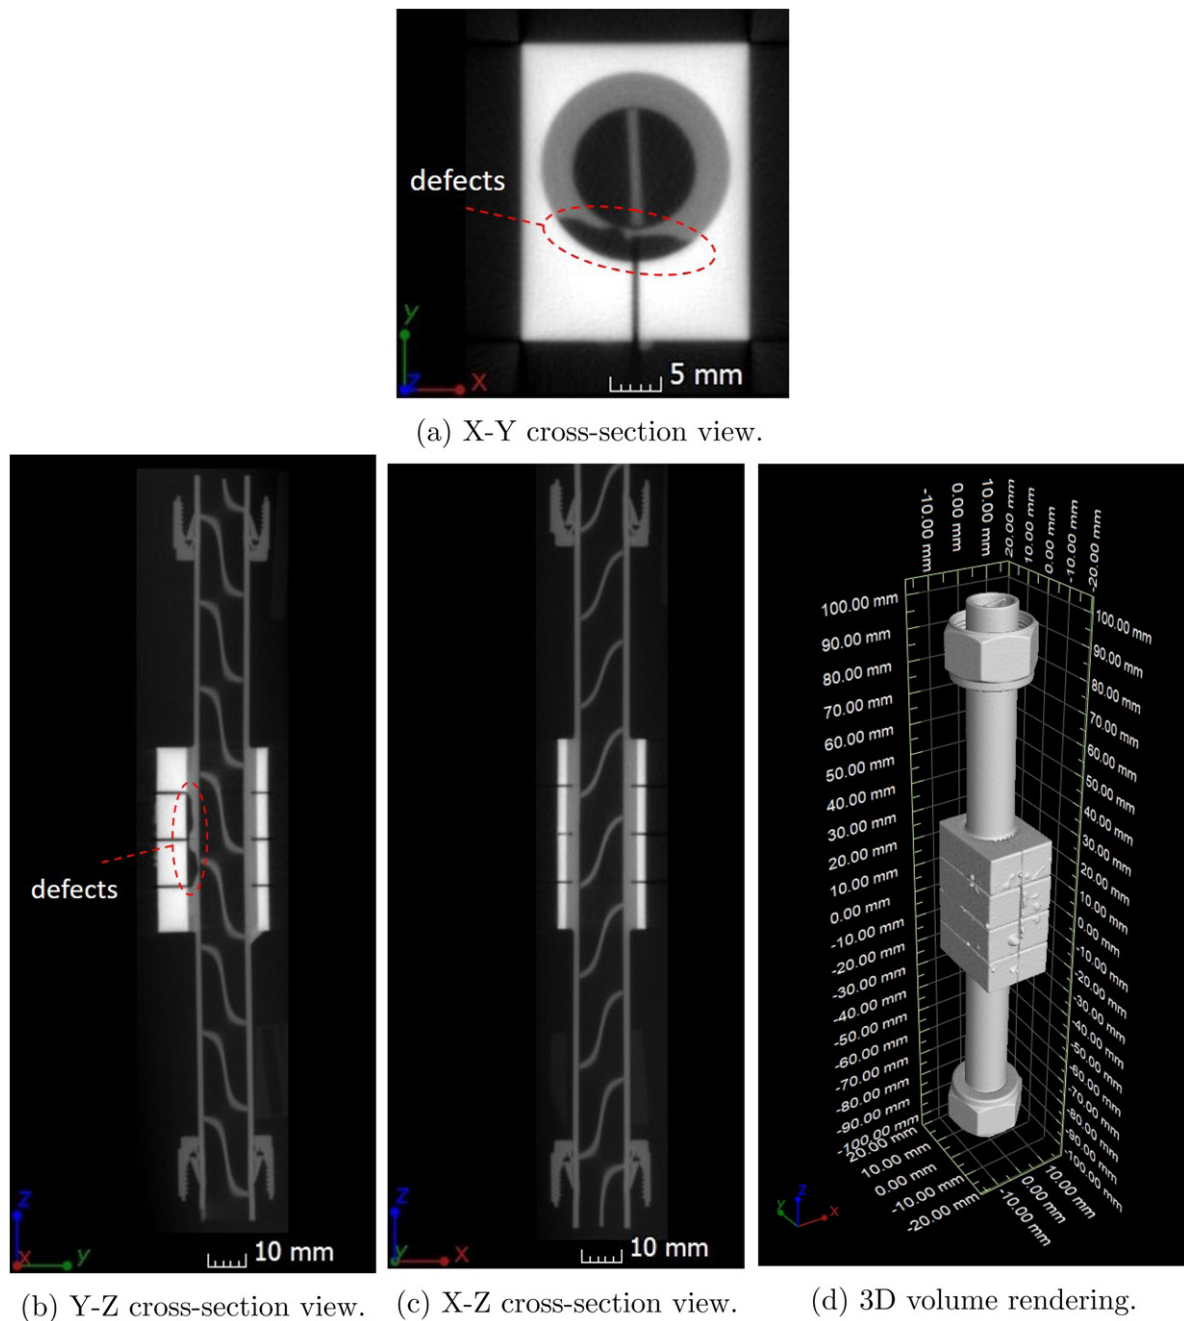
Figure 3. Cross-section views and 3D volume rendering of the DEMO divertor mock-up extracted from XCT data at MeV energy range.

In this section, we will discuss results showing volumetric defects present in the DEMO divertor mock-up caused by the HHF test performed on the HIVE facility [17] at UKAEA. The specimen was studied non-destructively with a spatial resolution (voxel size) of $139\ \mu\text{m}$ and a geometrical unsharpness of $119\ \mu\text{m}$. Smaller defect sizes with respect to the achieved spatial resolution were considered to not be distinguishable with the current experimental setup. After FBP reconstruction, some selected cross-sectional views of the specimen are reported in figures 3(a)–(c) and the full volume rendering of the object is shown in figure 3(d). From these results, damage

The x – y cross-section image of figure 3(a) has further revealed a complete loss of the structural integrity of the pipe in the proximity of the joints between monoblocks where the

pressure relief after boiling has resulted in the formation of some holes in the pipe with the subsequent loss of coolant. The good spatial resolution achieved in the tomography scan is also testified by the level of detail in the reconstruction of the threads of the two pipe fittings utilised to attach the mockup to the external cooling loop during the HHF test on HIVE, and visible in the y - z and x - z cross-section images of figures 3(b) and (c). Further, in the scan we been able to resolve details of

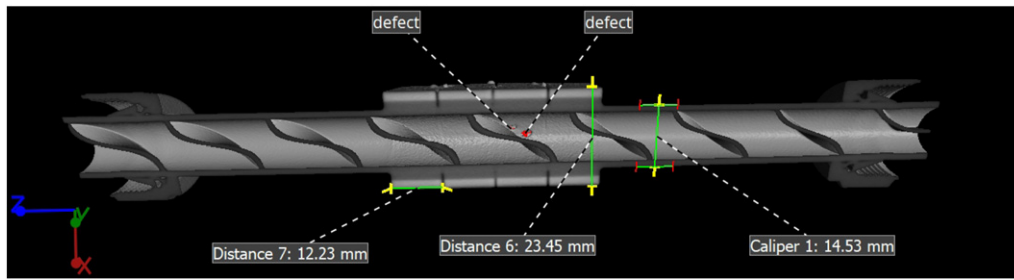
Figure 4. Volume rendering of the inner structure of the DEMO divertor mock-up where holes in the CuCrZr pipe have been highlighted ('defect' label). Metrology checks of some dimensions of the component were super-imposed as well for completeness.

the inner structure of the divertor target mockup and the helical swirl tape that runs through the entire length of the cooling pipe as shown in the cross-section images of figures 3(b) and (c), and in the subsequent figure 4. Figure 4 shows a 3D rendering of the divertor mockup where only about half of the component has been considered, this allows us to better understand the location of some of the holes present in the CuCrZr pipe, indicated in the figure with the label named 'defect'.

Metrology of the dimensions of the pipe outer diameter, W monoblock length, and monoblock thickness have been performed and are also visible in this figure. These measurements match very well with the dimensions of the component shown in the schematic drawing presented in the right panel of figure 1.

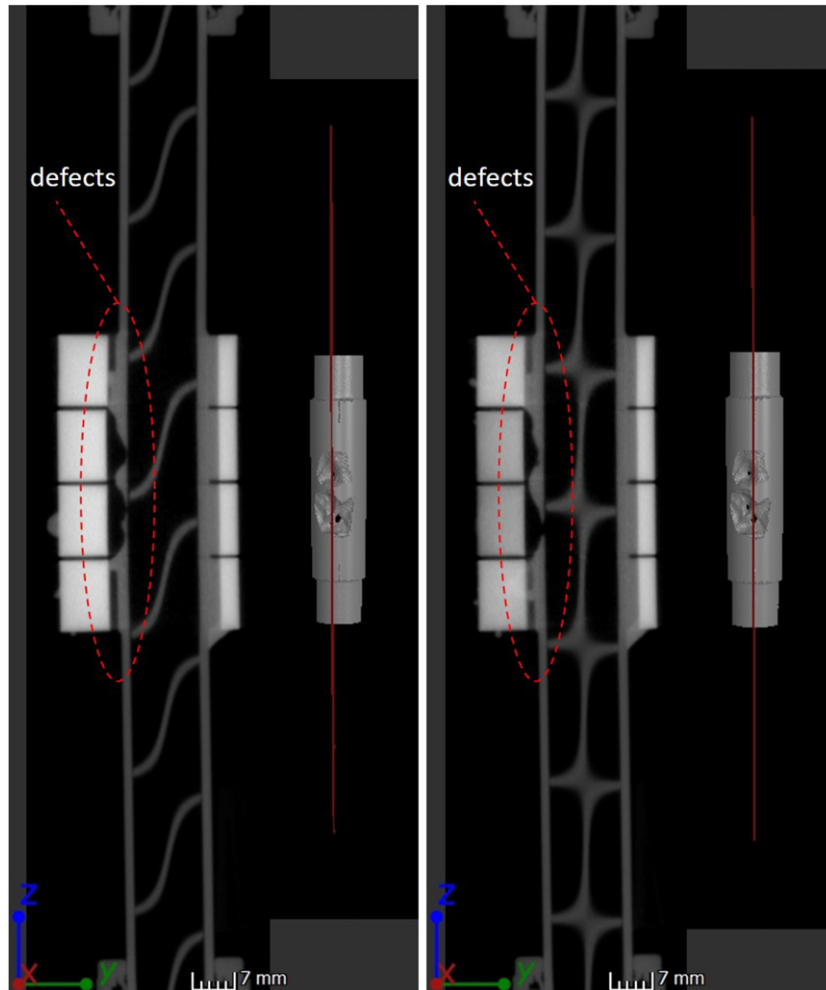
Figure 5. y - z cross-section views of the component in coincidence of the holes detected in the CuCrZr pipe. Left panel reports the first two pipe holes which are aligned vertically along the z axis, rather the third one is shown separately in the right panel of the figure. An insert displaying a 3D rendering of the component where W tiles has been masked (description provided in the main text) has been embedded in each panel for helping the reader localizing the cross-section image respect to the 3D rendering of the sample.

A better representation of the damage caused by failure during HHF load of the component has been achieved via virtual removal of the W tiles of the mock-up and obtained by masking with a cylindrical region of interest aligned in the respect to the pipe axis in the volume rendering of the sample. The result of this procedure is visible in the insert image embedded in each panel of figure 5. This image shows large melting regions in the OFHC copper interlayer and holes in the CuCrZr pipe of the specimen. Cross-section views depicted in figure 5 highlight the presence of three holes in the CuCrZr pipe which as previously said, are all located in the two central monoblocks of the divertor target. Two holes are visible in the y - z cross-section shown in the left panel of figure 5 because they were vertically aligned along the z axis. The third hole in the CuCrZr pipe is then depicted in the y - z cross-section image on the right panel of the same figure.

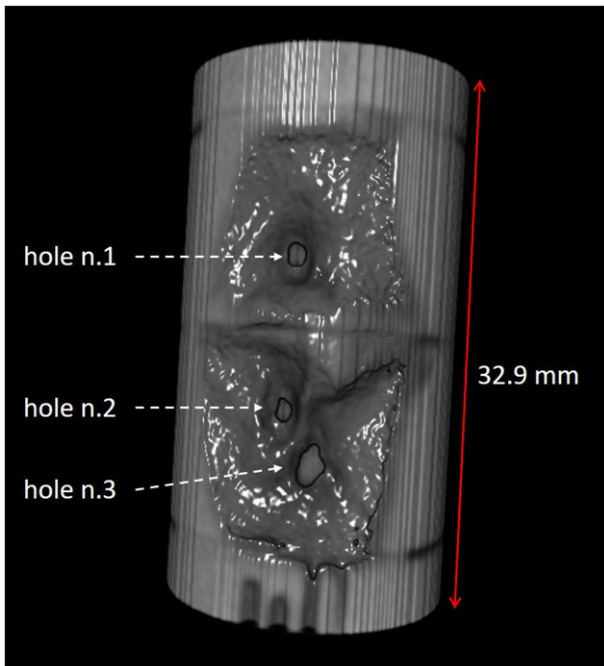
Figure 6. 3D rendering of the damage of the component caused after the HHF test performed on the HIVE facility.

To quantify the amount of material lost, a section of the volume close to the damage of the mock-up has been considered and shown in figure 6. This section has been obtained by extracting a sub-volume from the previous 3D rendering of the divertor target depicted in figure 5 where we hidden from the CT data the internal swirl tape volume with a similar procedure applied for masking the external W tiles discussed before. After manufacture and before any damage caused by the HHF load this selected section of the sample has a cylindrical shape with an external diameter of 19 mm if we sum the OFHC copper interlayer thickness of 4 mm to the pipe outer diameter

of 15 mm, an internal CuCrZr pipe diameter of 12 mm, and a length of 32.9 mm (as deduced by figure 6). With these dimensions its estimate overall volume is 5607.193 mm^3 within the assumption of a perfect cylindrical symmetry. Instead, the analysis of this section performed by means of VGSTUDIO MAX [21] has revealed a total volume of $2463.480 \pm 0.003 \text{ mm}^3$, i.e. a net loss of $3143.713 \pm 0.003 \text{ mm}^3$ of melted materials which have been partially deposited on the W tile surfaces of the component (see photo of the sample in figure 1).

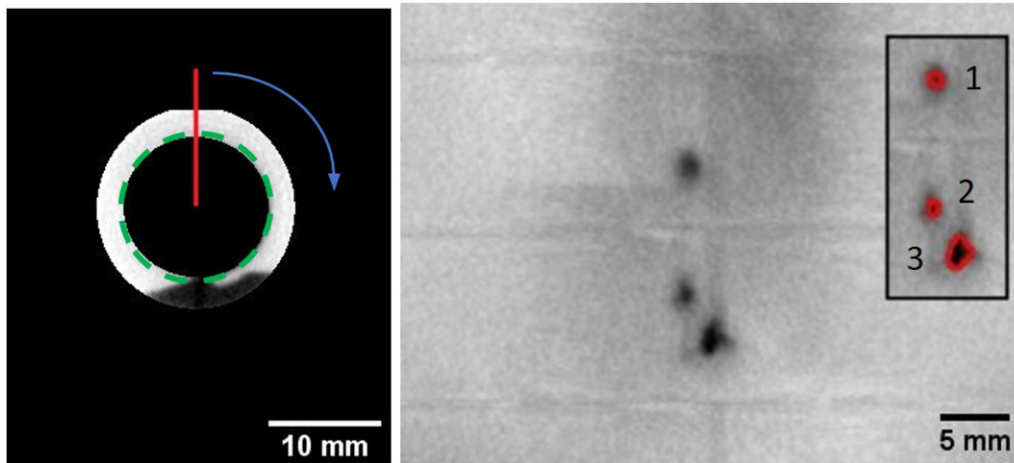
The quantification of the surface of each hole detected in the cooling pipe has followed a differ data analysis route because to its irregular geometrical shape, and it has been based on the idea of unrolling virtually the volume for the section of sample depicted in figure 6. The direction of unrolling is clockwise as highlighted by the blue arrow in the left panel of figure 7 which has been superimposed to a cross-section view of the analysed volume. From the resulting unrolled volume a slice close to the inner diameter of the pipe (following the dashed green line in figure 7) has been extracted and it is shown in the right panel of the same figure.

As expected, the holes in the CuCrZr pipe have an irregular shape difficult to evaluate with simple geometrical calculations. The computation of each hole dimension has required first the detection of its contour, after which the area could be evaluated knowing the pixel size. This has been done automatically by applying the 'analyze particles' plugin [22] available for the ImageJ software [23] to the unrolled slice. The contour limit of each hole area is visible in the insert of the right panel of figure 7 and drawn in the image as a solid red line. Table 1 shows the outcome of the analysis where we report the area of each pipe hole in square millimetres obtained by computing the number of pixels falling within each contour, its error set to be equal at the area of one pixel, the ellipse aspect ratio, and ellipse roundness after fitting the contour with an ellipsoidal function.

Figure 7. (Left panel) Virtual unrolling direction of the analysed CT volume for the section of component in figure 6 together with the indication where the slice from the unrolled volume has been taken, and reported as a dash green line in the image. (Right panel) Slice of the unrolled volume used to quantify the area of the cooling pipe holes in the DEMO divertor mock-up. The insert in figure shows the contour limit of each hole area computed by means of ‘analyze particles’ plugin [22] available for ImageJ software [23].
