UKAEA-CCFE-CP(20)83

Post-test examination of a Li-Ta heat pipe exposed to H plasma in Magnum PSI

The authors exposed a radiatively cooled, Li-filled tantalum (Ta) heat pipe (HP) to a H plasma in Magnum PSI continuously for ~2 hours. We kept the overall heat load on the inclined HP constant and varied the tilt to give peak heat fluxes of ~7.5-13 MW/m². The peak temperature reached ~1250° C. This paper describes the post-test analysis and discusses Li HPs with materials other than Ta for fusion. A companion paper describes the experiment.

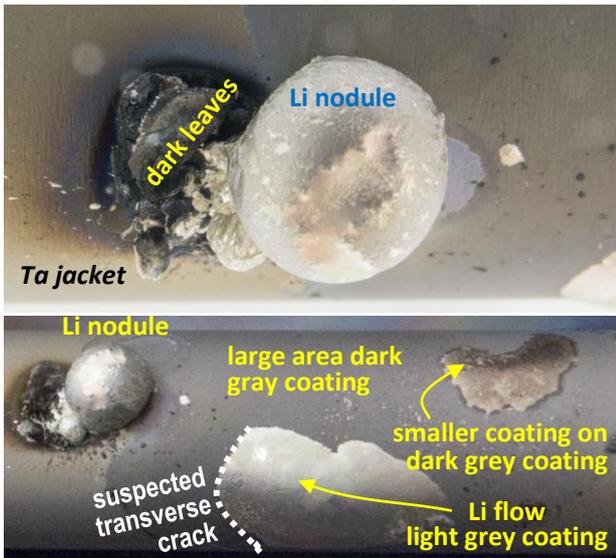
Figure 2. Li-Ta HP just after removal from Magnum PSI.

After the dark grey coating had formed, the well-resolved live image of the 2nd IR camera showed Li flow from what appeared to be a transverse crack as indicated by the curved and white arrows in Fig. 2. This light grey coating wetted an area ~30 mm² and thickened with a slight bulge. The description here is a recollection of the live image. The IR camera had stopped recording before this time, and the flow was not visible in the video cam.

Other details became apparent in the post-test observations. Fig. 2 was taken on a workbench while the HP was briefly exposed to air. The nodule and light grey coating were shiny at first. Then, slowly oxidation began to reveal the grain boundaries, which are apparent in the images. The smaller coating also flowed over the dark grey coating and, we presume, was formed by the same process as the light grey coating since both overlay the dark grey coating and have closed perimeters. Adjacent to the nodule are the dark fans of a leaf-like structure.

The image of Li flowing from a crack (Fig. 2) to form the light grey coating was compelling. An explanation that the crack was in the dark grey coating rather than the Ta jacket is consistent with items 1-4 below.

We conclude that the coating was brittle and cracked, and that Li flowed through that crack from channel(s) under the dark grey coating to form the light grey coating.

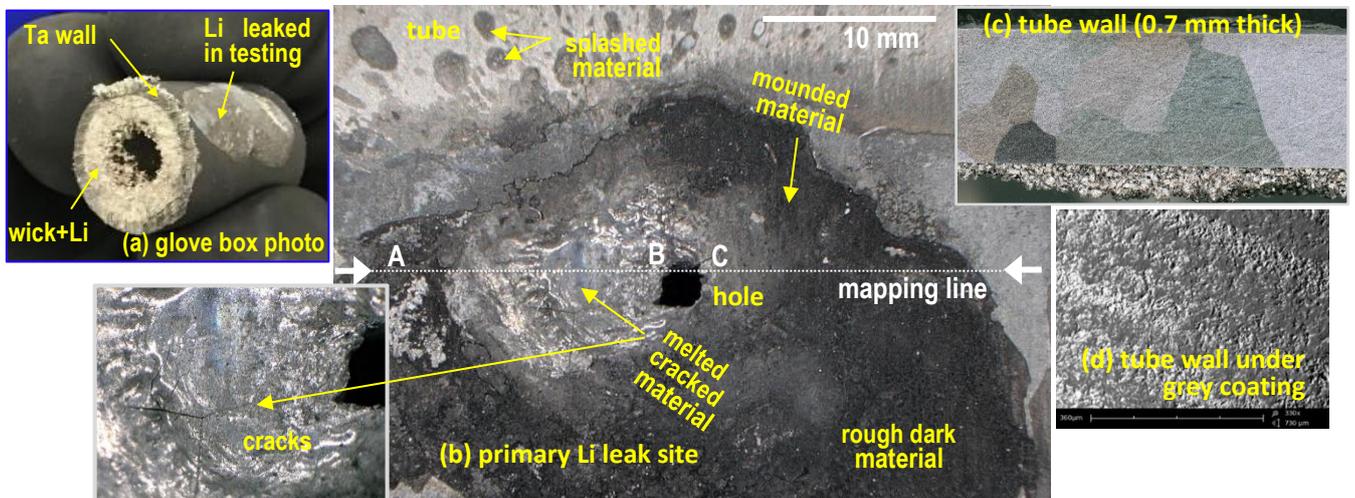
Figure 3. (a) glove box photo, coatings, no nodule; (b) primary Li leak site, 0.2x0.3 mm hole; (c) Microstructure of 0.7-mm-thick Ta wall; (d) Ta tube surface under grey coatings.

Figure 3b shows the pinhole failure site of the primary Li leak. Splashed and mounded material overlaid the tube surface. Mounded surfaces located at A and C in Fig. 3b were ~40 μ above the tube wall. The shoulder (B) of the deep hole is ~250 μ below the tube prior surface. To the left of the hole is material that had melted and cracked.

In the microstructure of the Ta wall (Fig. 3c), the large grains indicate recrystallization. In some locations a single grain spanned the wall thickness.

Examination in an SEM of the surface under the light grey and dark grey coatings (Fig. 3d), revealed some damage (a few small holes). However, a large crack in the position indicated in Fig. 2 was not found. The surface under the coatings was like the other side of the pipe which was also hot but not but not exposed to plasma.

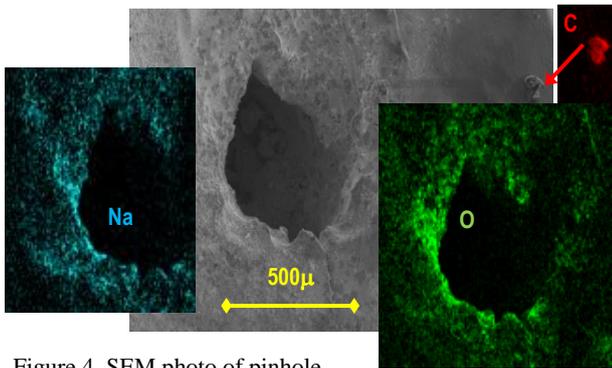
Figure 4. SEM photo of pinhole leak site and elemental maps of surface impurities.

Figure 4 shows element maps of surfaces at the primary leak site. Oxygen (O) and sodium (Na) were significant. A small blob of ejected carbon (C) or a carbide was found but C was not widespread.

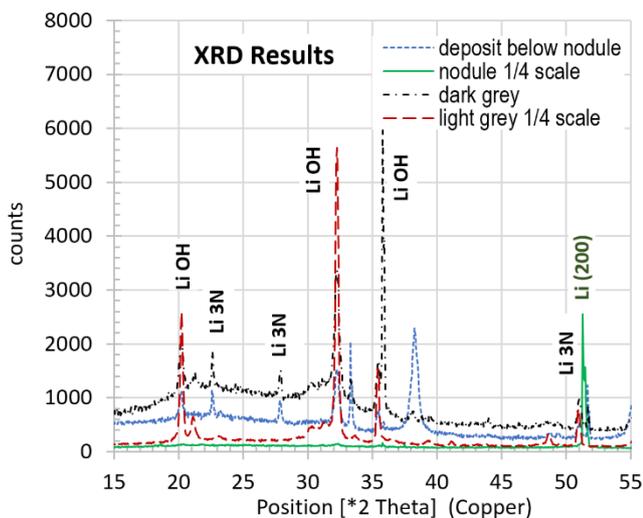
Fig. 5. XRD results for the Li nodule and coatings.

Strong (200) and (211) lines indicate that the nodule was metallic (amorphous) lithium. The coatings contained crystalline material. The dark grey coating was composed of LiOH and Li₃N, as was the black deposit below the nodule. The latter had trace amounts of an unidentified phase. The light grey coating was predominantly LiOH.
