UKAEA-CCFE-PR(23)06

JET Exhaust Detritiation System replacement – design, commissioning, and operation

3. Corrosion and failure of previous EDS

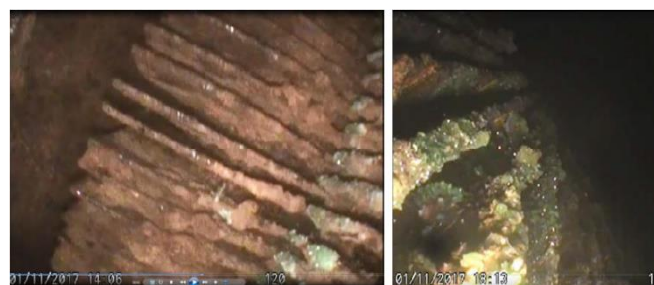
Figure 1 – Internal inspection pictures of cooler / condensers' heat exchanger surfaces

Figure 1 is a typical image exhibiting clear indications of corrosion on Heat Exchanger surfaces. The surfaces themselves were heavily contaminated with debris build-up, corrosion products and crystallised salts. Some surfaces also appeared wet, suggesting deliquescence due to salts present on the internal surfaces.

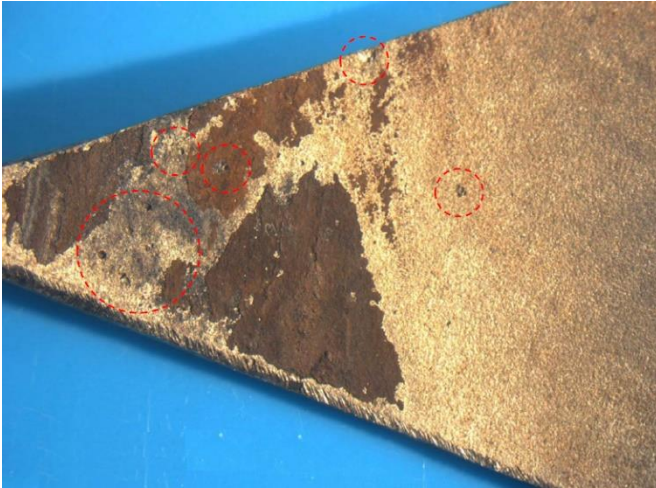
Figure 2 – Section of pipework with pitting revealed after partial removal of surface deposits

From Figure 2, the colour of the deposit is indicative of iron-based corrosion product (haematite) but the structure of the deposits does not match a corrosion scale growth (e.g. from general corrosion); the ‘mud-cracking’ feature indicates deposition of fine particles from a liquid. Removal of the deposits revealed substantial pitting and indications of Inter-Granular Attack (IGA).

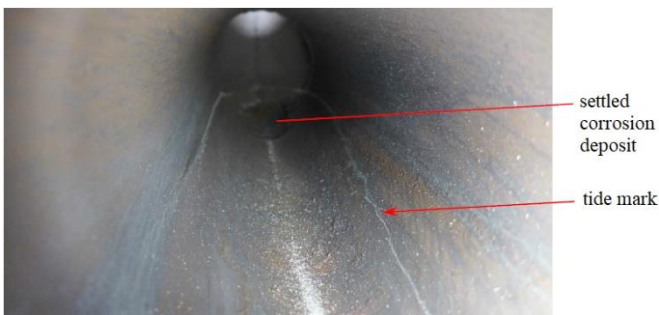
Figure 3 – Internal image of 5" pipe demonstrating settled deposits and the presence of a tide mark

Figure 3 shows 5" horizontal pipework with tide marks indicating build up of water in the bottom of the line whilst the top of the pipe is in better condition.

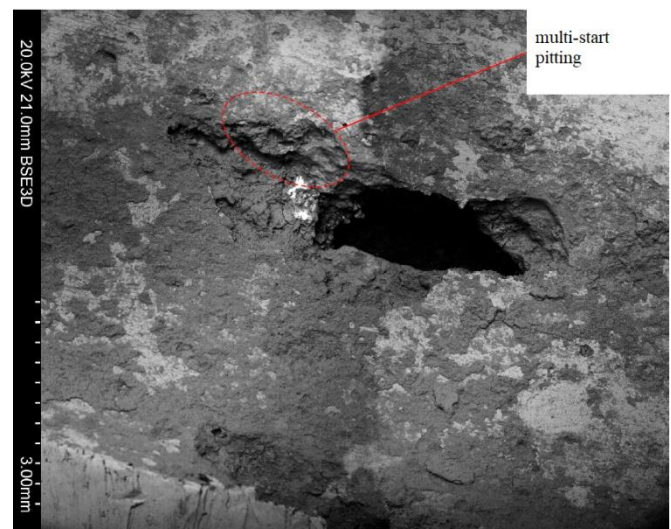
Figure 4 - Scanning Electron Micrograph of perforation (location of pipe failure)

Figure 4 is a SEM image of the hole in the ½" condensate pipe caused by pitting corrosion, this pitting was initiated by deposits of corrosion products, that were not solely generated locally to the hole. These formed occluded corrosion cells where localised anodic corrosion sites experienced stabilised auto-catalytic pitting. Localised thinning in this location was covered by further deposits suggesting an extended operational period following the failure. Figure 5 shows further evidence of pitting corrosion.

As a result of the extensive corrosion observed, the decision made was that EDS repair was not viable. Instead the entire system (up to but excluding the ADT) has been replaced.

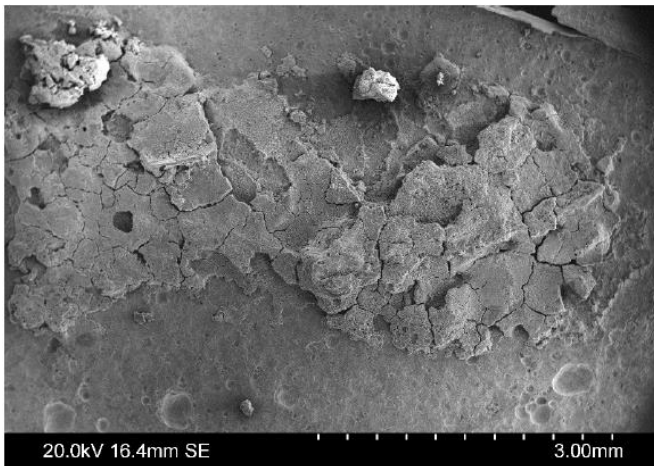
Figure 5 - pitting revealed on sample surface after partial removal of surface deposits using Clarke's solution

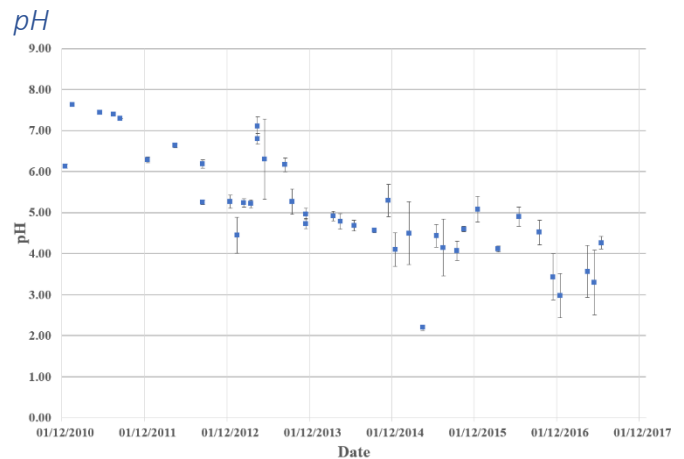
Figure 6 - Averaged pH levels from Active Drain Tank samples 2011-2017, including standard deviations

Routine liquid sampling (Figure 6) has demonstrated a pH as low as 2; upon plotting the data, it can be seen pH has slowly reduced over the years from reading around 6.5 in 2011 to around 3.5 in 2017, at which time EDS failure occurred.

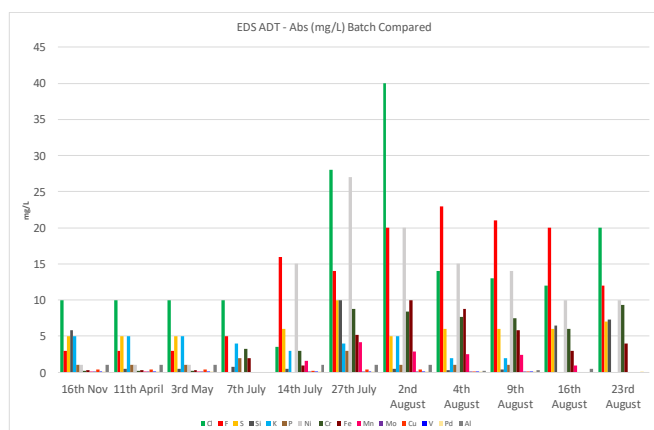
Figure 11 - Ion concentration in the Active Drain Tank

Elemental and ionic analysis of ADT water is shown in Figure 11. The Cl levels after passing through the AGHS are at 10mg/L from the 16th November to 7th July. There is also 2 mg/L of fluorine until the 7th of July where it doubles to 5mg/L, corresponding to an increase in Cr and Fe. The 14th July sample shows a decrease in Cl but a rise in F and Ni also increases. From 27th July sample other components associated with 316 stainless steel construction (Fe, Cr, Mn) also rise correspondingly. The data shows the evolution of halogen ingress and corrosion with time, with increased amount of corrosion product reaching the ADT by 27th July.

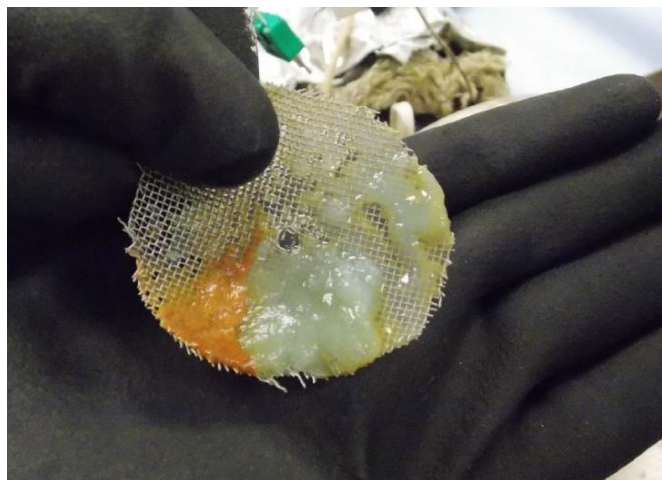
During HF testing, flow blockage was encountered. Upon inspection of the column, a gel like substance Figure 13 had been produced which was causing the soda lime balls to clump together and reduce flow path (see Figure 13). Heavy build-up of deposit was observed on the inlet tube (Figure 14). The soda lime was deemed incompatible with HF, the probable cause being the sodium hydroxide content present within the soda lime, as suggested by the high sodium content of the gel.

Figure 13 - gel deposit on test column diaphragm produced during acute HF testing Intersorb

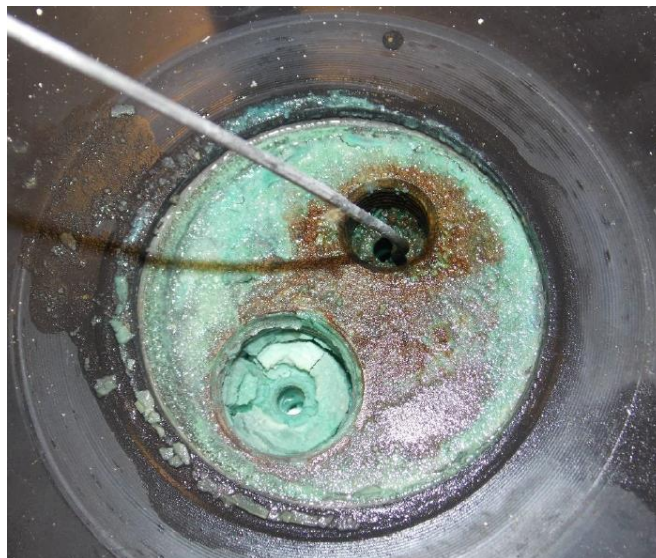
Figure 14 - corrosion product build-up on bottom flange and inlet pipework during acute HF testing Intersorb (note larger penetration was not used)

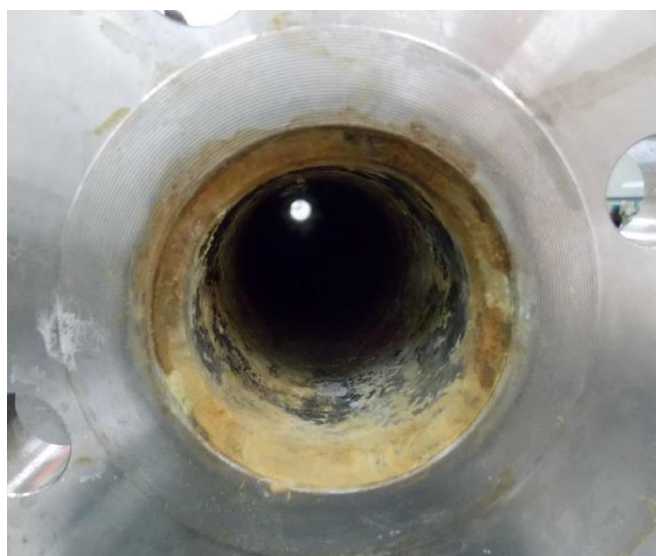
Corrosion of the test rig was observed, severe at the bottom (Figure 15) and light pitting at the top (Figure 16, the latter thought to be caused during rig commissioning).

Figure 15 - corrosion within the inlet of the test rig column during acute HF testing Intersorb

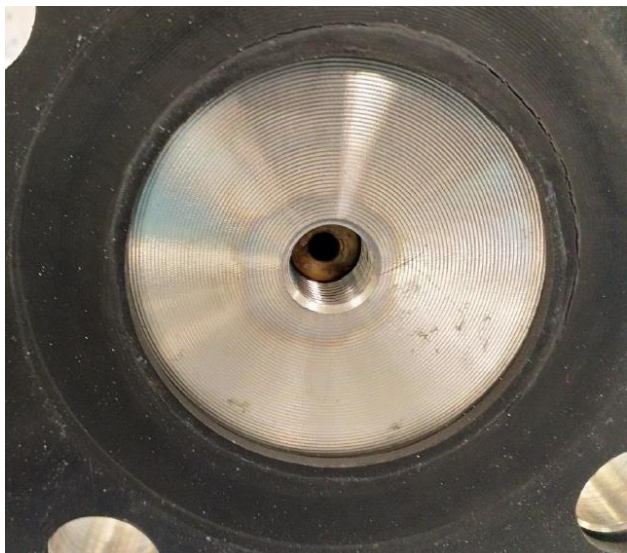
Figure 16 - light pitting corrosion on outlet flange during acute HF testing Intersorb

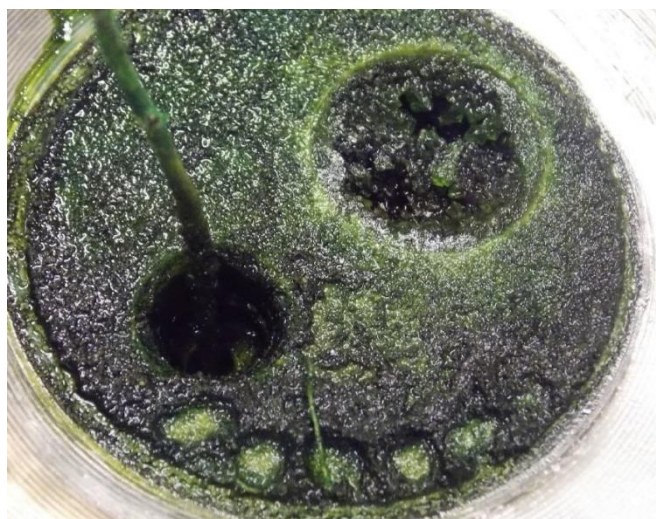
A chronic test of Verdal was conducted, for four weeks; no acid was detected at the column outlet during this time. However, inspection of the rig identified a green residue around the bottom (Figure 18).

Figure 18 - green residue build-up on bottom flange following chronic HCl testing of Verdal

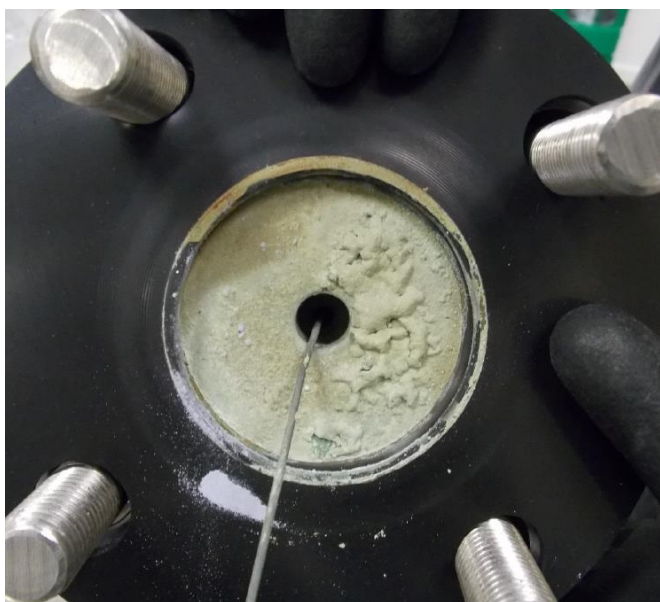
Figure 20 - thin layer of deposit on bottom flange following chronic HF/HCl mix test with Loflosorb

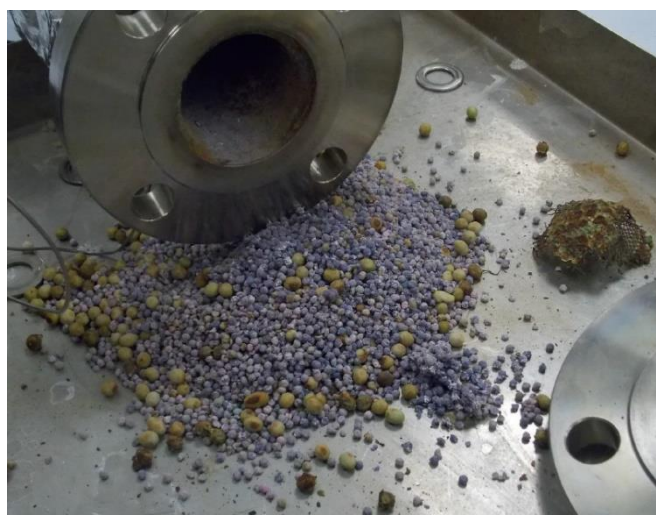
Whilst corrosion deposit was observed at the column inlet, the Loflosorb itself was in good condition (Figure 22). No corrosion was observed at the column outlet (Figure 23) and no breakthrough acid detected in the bubblers. The result of two week and three week tests were consistent. The three week test ultimately had equivalent of 14.6 months chronic acid loading.

Figure 22 - following accelerated chronic testing, Loflosorb (purple balls) came out in good condition.

Following this final test, the Loflosorb was formally approved for use by UKAEA.

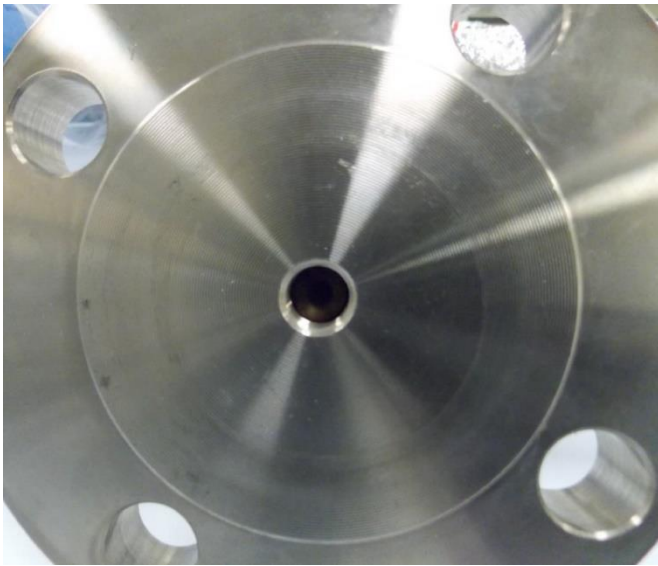
Figure 23 - Following accelerated chronic testing of Loflosorb, outlet flange was clean and free from corrosion.

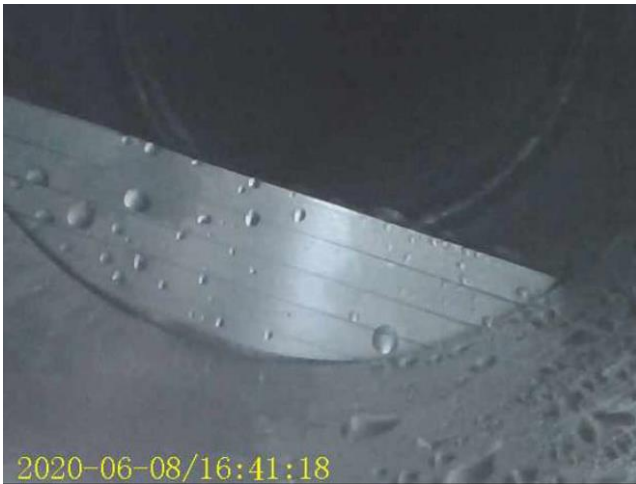
During regeneration cycle tests, water carry over past the condenser to the blower was observed. This was evidenced by the thermal mass flowmeter returning an overrange error due to moisture ingress increasing the heat capacity of the fluid, and increased vibration of blowers. Indeed, water was found in the base of one blower casing during invasive investigation. A camera was installed at the outlet of the condenser and water could then be seen as droplets 'raining' through the pipework during the dryer regeneration. The solution consisted of the installation of a dam on the outlet of each condenser, to reduce the carry-over, and lowering the blower speed during the regeneration cycle.

Figure 24 - Condenser outlet camera showing the dam installed for Dryer 3. Water droplets and a pool forming can be seen during regeneration on 8th June 2020

Tests were conducted watching the camera in real-time, to determine the maximum possible flowrate without water droplets visibly going over or hitting the dam. This solution was effective, but the dryer regeneration is approximately twice as long (from 15 to ~30 hours) due to the reduced blower speed.

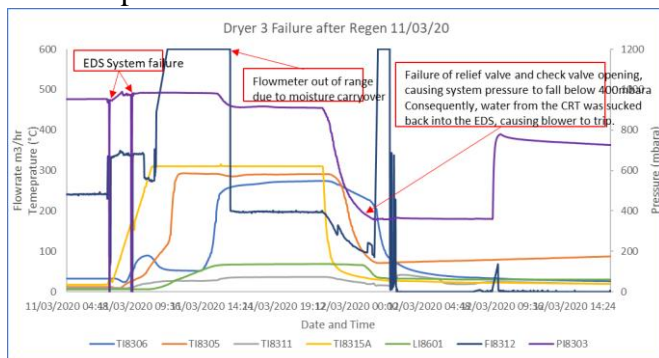
During a dryer regeneration cooldown, the vacuum relief valves failed to operate at the opening pressures, so the pressure dropped to 380 mbar(a), sufficient to syphon water back up from the CRT. The water flooded the condenser and ran down to the blower, eventually tripping the blower on high inlet temperature.

Figure 25 - Dryer 3 Regeneration: Ingress of water from Condensate Relay Tank, 12th March 2020

The valves were removed for inspection and confirmed to require higher differential pressure than specified to open. Half of the valves have been replaced with valves with metal to metal seats, and all were recalibrated with lower opening differential pressures. Software modifications were also made to close the condenser drain valve during regen cooldown or if pressure < 600 mbar(a) detected in the dryer circuit. No similar incidents have occurred.
