## Post-test examination of a Li-Ta heat pipe exposed to H plasma in Magnum PSI

The authors exposed a radiatively cooled, Li-filled tantalum (Ta) heat pipe (HP) to a H plasma in Magnum PSI continuously for ~2 h. We kept the overall heat load on the inclined HP constant and varied the tilt to give peak heat fluxes of ~7.5–13 MW/m<sup>2</sup>. The peak temperature reached ~1250 °C. This paper describes the post-test analysis and discusses Li HPs with materials other than Ta for fusion. A companion paper describes the experiment.

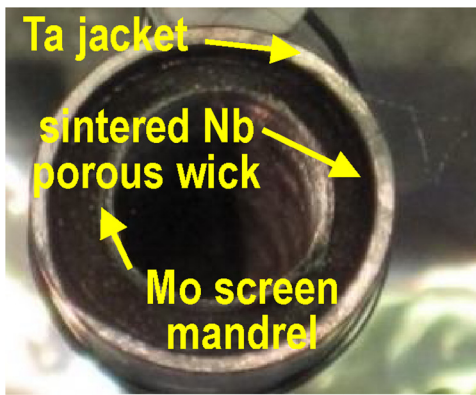
Fig. 1. Li-Ta HP before end cap weld.

An SEM exam of the surface under the light grey and dark grey coatings (Fig. 3d), revealed a few small holes but no large crack at the site shown in Fig. 1. The surface under the coatings was like the other side of the pipe which was had been hot but not but not exposed to plasma.
