JET exhaust detritiation system replacement—design, commissioning, and operation

To cite this article: Robert George *et al* 2023 *Plasma Phys. Control. Fusion* **65** 064002

¹ H3AT Division, UKAEA, Abingdon, United Kingdom

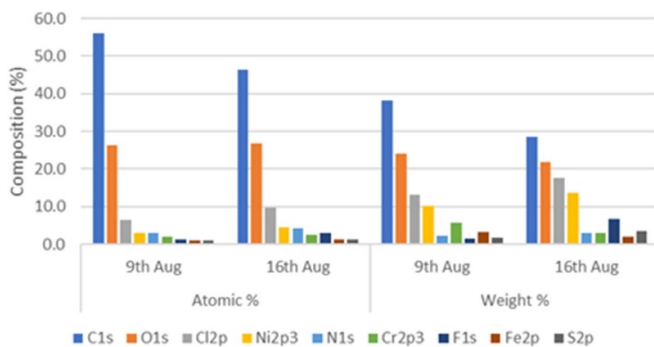
Figure 9. Chemical analysis of evaporated active drain tank samples.

3.5.3.1. Wet samples. The XPS results identify the elements present within the wet samples taken from EDS. For the ADT (figure 9) and CRT (figure 10) there are fluorides and chlorides, all bound to cations, nitrogen bound up as mixed quaternary ammonium salts, nitrates and amines. All metallic components were found to be in ionic, non-metallic states, bound to a mixture of chlorides, fluorides and oxides.

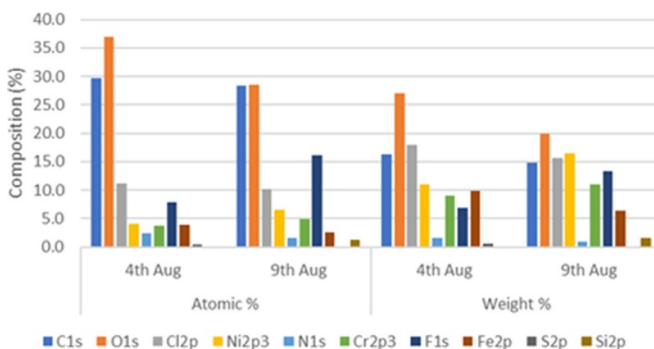
Figure 10. Chemical analysis of evaporated condensate relay tank samples.

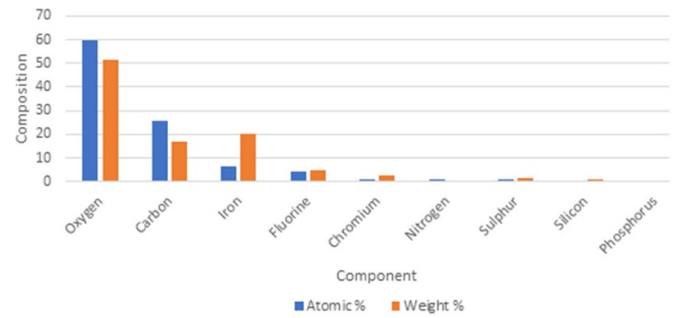
Figure 11. Surface composition by x-ray photoelectron spectroscopy of active drain tank slurry.

Samples of slurry (figure 11) taken from the bottom of the ADT tanks were analysed and were found to be, ignoring the carbon over layer, predominantly Fe(III) oxide, with small amounts of likely Cr(III) fluoride.

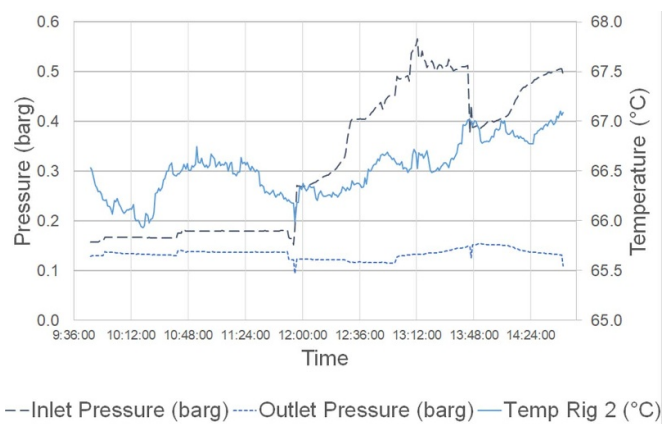
Figure 18. Inlet pressure rise observed during acute HF testing of KPAB on 26 November 2018.

(figure 18) and gel/deposit was observed at the base of the column in each case. Verdal performed slightly better.

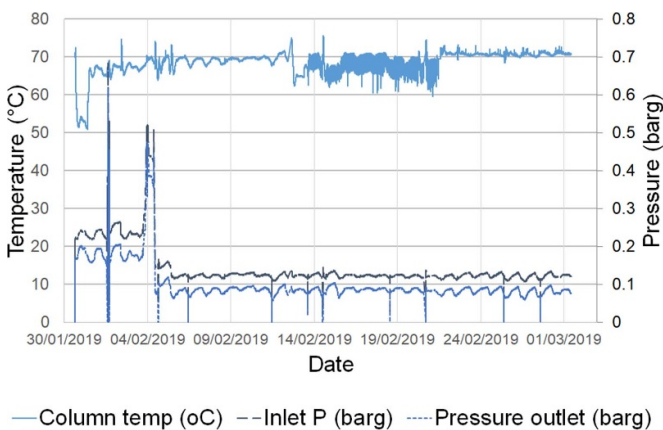
Acute and chronic testing was performed on Loflosorb, which is free from potassium- and sodium hydroxide. Performance during these tests was good, both in terms of no detectable acid at outlet, and stable pressures throughout the tests (figure 20). A very fine layer of light deposit was observed on the inlet flange (figure 21), note that the raised areas of

Figure 20. Chronic HF/HCl mix test with lofosorb. Pressures remained stable throughout testing.

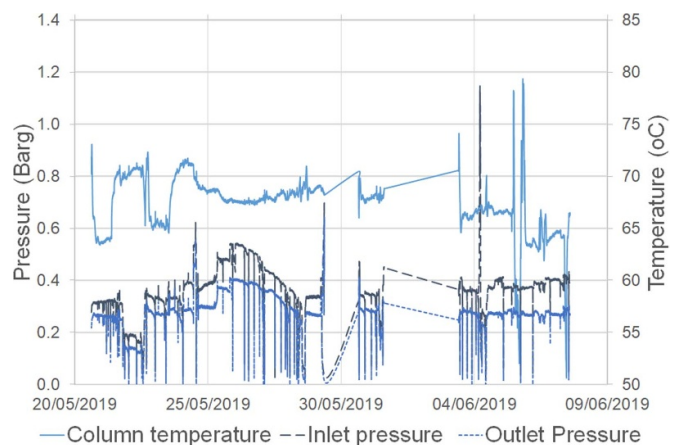
4.2.3.4. Testing and results phase III. The final phase was an ‘accelerated chronic’ test, to demonstrate equivalent loading from a full 10 month chronic event, but condensed over two or three weeks testing. As well as scaling acid loading, water vapour and CO₂ were injected with dosing equivalent to 10 months within the 2 or 3 week test. Flowrate through the column was 35 l·min⁻¹. This stressed the test rig, with significant corrosion occurring in the inlet pipework, causing blockages that required periodic clearing to allow testing to continue. The impact on pressures can be seen in figure 22.

Figure 22. Accelerated chronic test trend for Loflosorb.

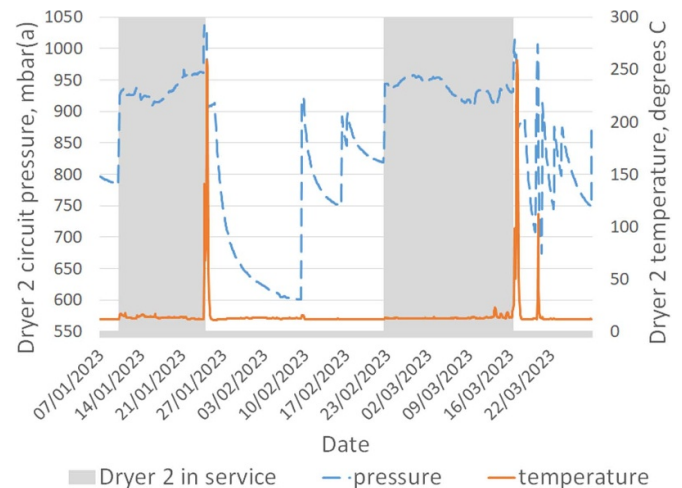
Figure 35. Dryer 2 pressure reduction following regenerations on 24 January 23 and 16 March 23.

6.4.2. Dryer behaviour. Following dryer regenerations, dryer circuit pressure continues to reduce below atmospheric (and below the EDS operating pressure), even after the temperature has returned to ambient. This continues with the dryer in standby mode. The vacuum can be relieved by manually opening a valve which allows top up of gas from the dryer outlet manifold and another route allows this to happen automatically if the low pressure setpoint of a passive vacuum relief valve is reached. The probable cause is that the molsieve is absorbing residual water vapour from the closed loop, reducing the total gas pressure.

Figure 35 shows the Dryer 2 behaviour over two regeneration cycles. The post-regeneration temperature drops back to ambient relatively rapidly, hence this can be ruled out as the cause of the pressure reduction which occurs over a much longer period. The rapid recoveries in pressure occur on temporary opening of the vent valve. The rate of pressure reduction is observed to reduce over time. Unfortunately there is no humidity monitoring within the dryer circuit, however having ruled out temperature, there are no other credible causes of the pressure reduction other than that vapour adsorbing into the molsieve bed.

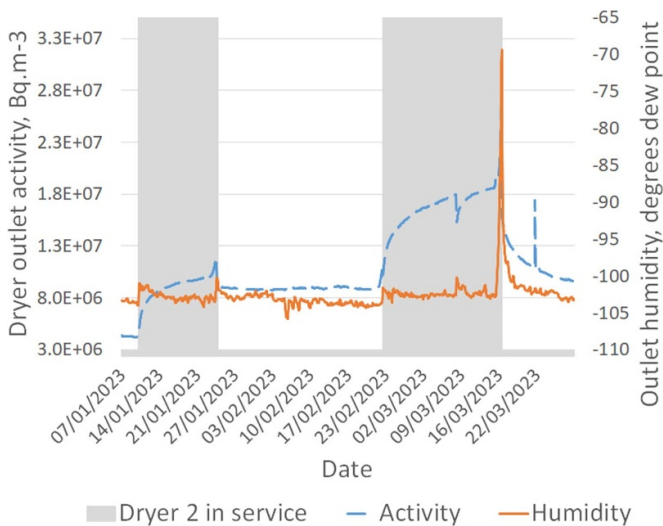
Figure 36. Outlet humidity and activity with dryer 2 and 3 alternating service.

Figure 36 shows outlet humidity and tritium concentration for dryers 2 and 3. The saturation of the dryer is indicated by an increase in the humidity and/or the tritium concentration, either of these cases triggers the operator to start a new cycle of dryer changeover and regeneration.
