UKAEA-CCFE-PR(23)06

JET Exhaust Detritiation System replacement – design, commissioning, and operation

3. Corrosion and failure of previous EDS

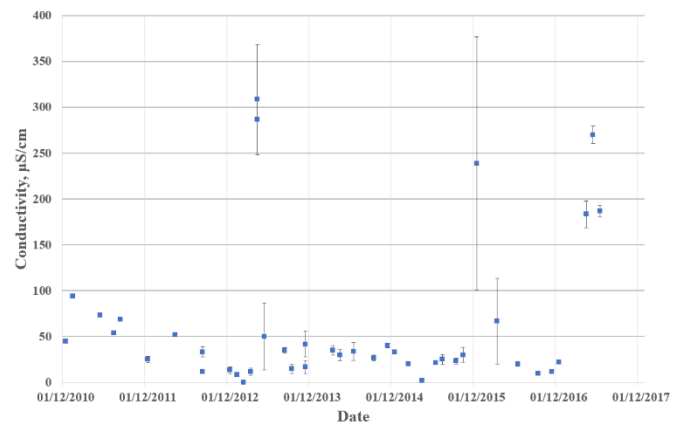
Figure 7 - Averaged conductivity from Active Drain Tank samples 2011-2017, including standard errors

The liquid sample conductivity (Figure 7) was relatively stable over time, but with at least one contamination event in 2013, and with an additional anomaly in December 2015, likely associated with the installation of the water detritiation system

(WDS). An order of magnitude increase is observed from April 2017.

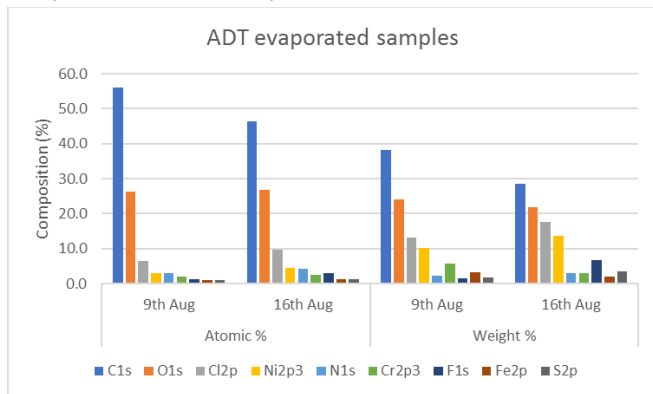
Figure 8 - Chemical analysis of evaporated Active Drain Tank samples

The XPS results identify the elements present within the wet samples taken from EDS. For the ADT (Figure 8) and Condensate Relay Tank (CRT) (Figure 9) there are fluorides and chlorides, all bound to cations, nitrogen bound up as mixed quaternary ammonium salts, nitrates and amines. All metallic components were found to be in ionic, non-metallic states, bound to a mixture of chlorides, fluorides and oxides.

The chrome is likely to be Cr(III) chloride, based on its binding energy, with the stoichiometry noted, the abundance of oxygen and the deposit colour, and water seen. This is likely in its dark green hexahydrate form, $\text{CrCl}_3(\text{H}_2\text{O})_x$.

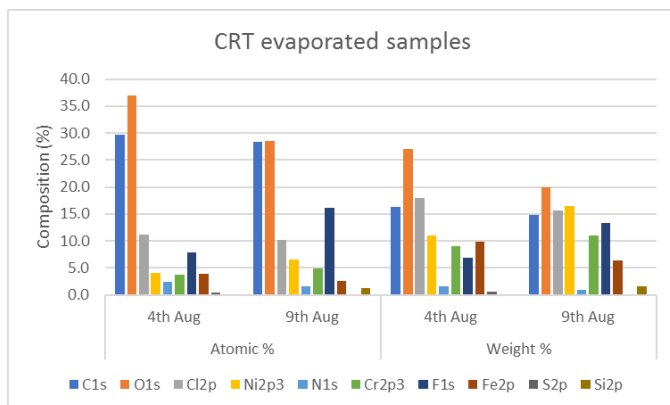
Figure 9 - Chemical analysis of evaporated Condensate Relay Tank samples

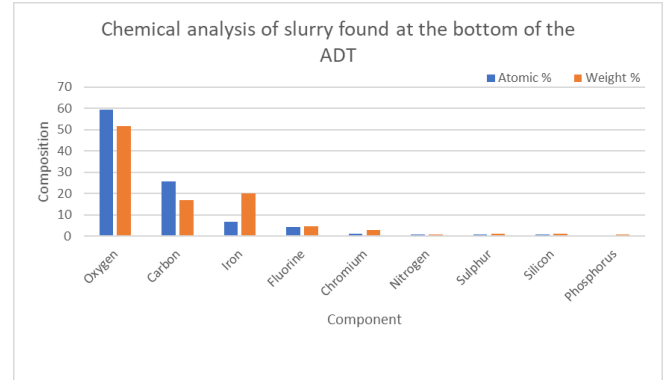
Figure 10 - Surface composition by X-Ray photoelectron spectroscopy of Active Drain Tank slurry

Samples of slurry (Figure 10) taken from the bottom of the ADT tanks were analysed and were found to be, ignoring the carbon over layer,

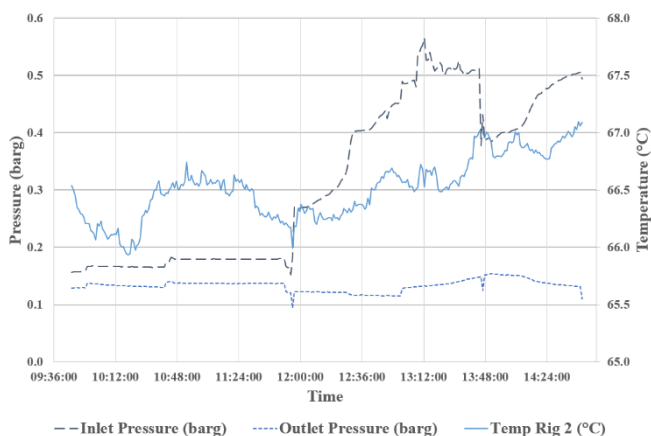
Acute testing of Verdal and KPAB displayed similar behaviour to the Intersorb. Pressure drop increased during the tests (Figure 17) and gel/ deposit was observed at the base of the column in each case. Verdal performed slightly better.

Figure 17 - inlet pressure rise observed during acute HF testing of KPAB on 26/11/2018

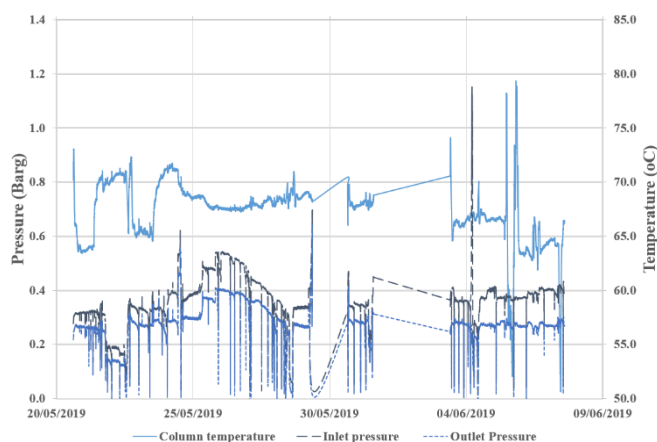
stressed the test rig, with significant corrosion occurring in the inlet pipework, causing blockages that required periodic clearing to allow testing to continue. The impact on pressures can be seen in Figure 21.

Figure 21 - accelerated chronic test trend for Loflosorb
